Investigating the Milun Fault: The coseismic surface rupture zone of the 2018/02/06 M_L 6.2 Hualien earthquake, Taiwan

Huang, S.-Y., J.-Y. Yen, B.-L. Wu, I.-C. Yen, and R. Y. Chuang, 2019: Investigating the Milun Fault: The coseismic surface rupture zone of the 2018/02/06 M_L 6.2 Hualien earthquake, Taiwan. *Terr. Atmos. Ocean. Sci.*, 30, 311-335, doi: 10.3319/TAO.2018.12.09.03

ABSTRACT

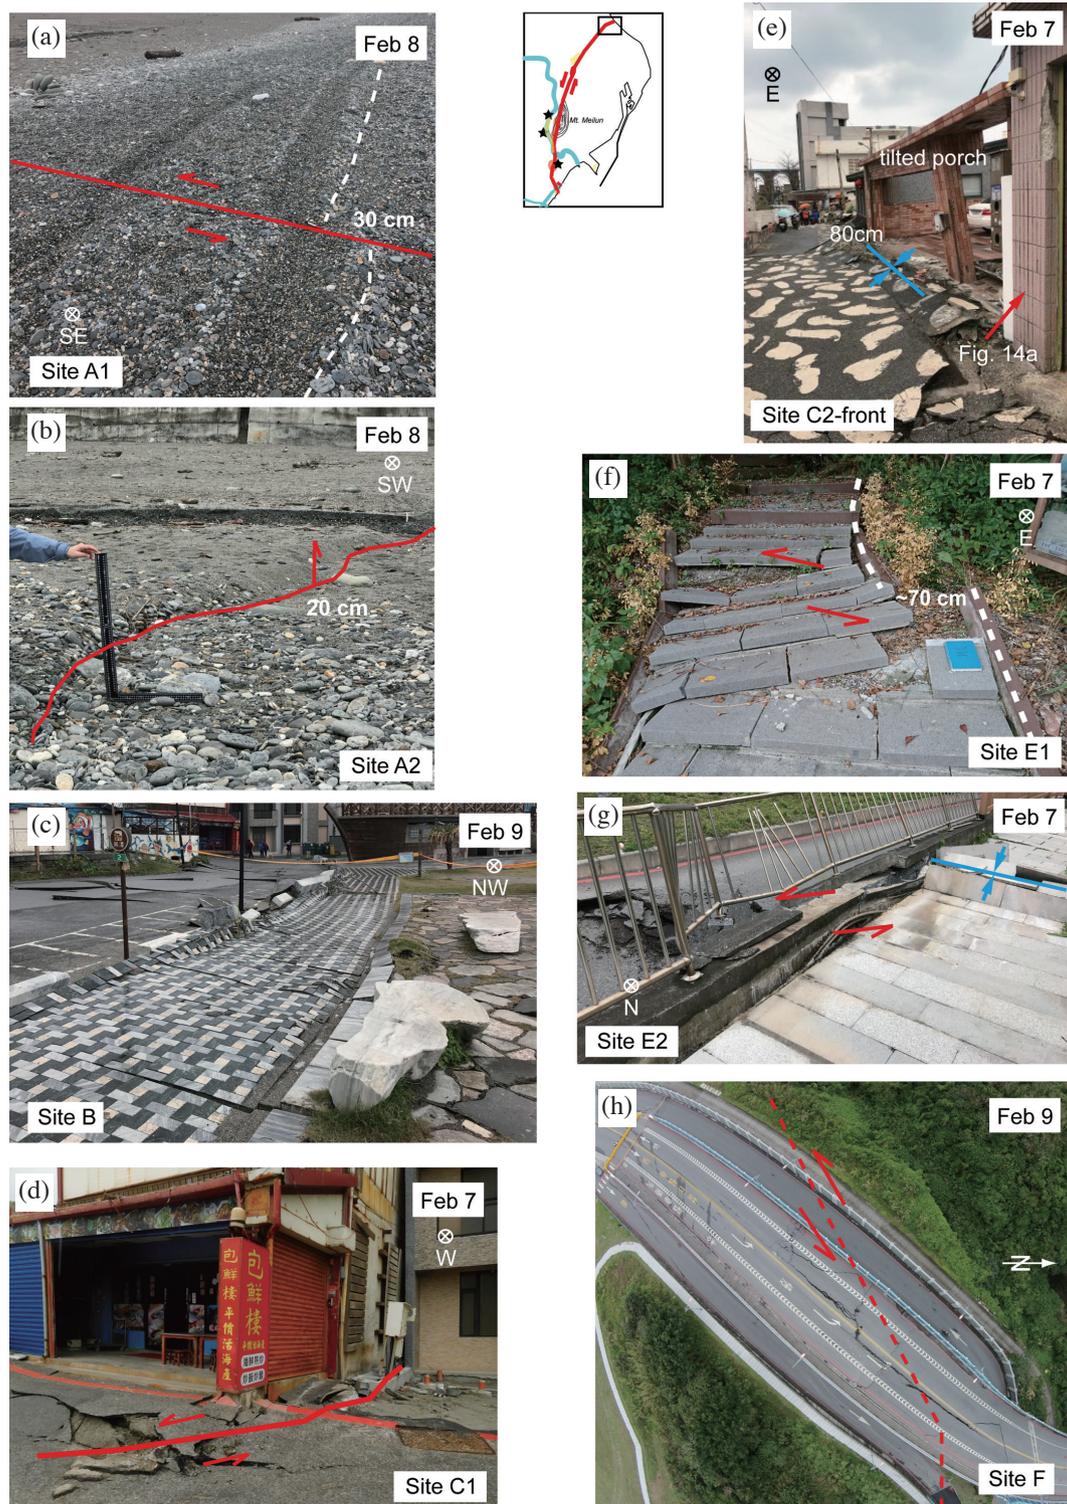
The northernmost rupture on-land occurred at the Chihsingtang Beach area (Fig. 3a) where two parallel lineaments of fault trace were observed on the gravel beach with a 30-cm-sinistral (site A1, Fig. 4a) and a 20-cm-uplift (site A2, Fig. 4b) offset, respectively. The dipping direction of the fault plane can be observed to east but the actual angle is hard to estimate because of the unconsolidated nature of gravel beach.

The ruptures in this area in general followed the strike of N60°E and extended southwestward from the beach. On the tarred parking lot adjacent to the beach, the fault generated arrays of both synthetic (10- to 30-cm-sinistral offset) and antithetic (10- to 50-cm-dextral offset) Riedel shears (site B, Fig. 4c). These shear also displayed vertical offsets along their sigmoidal ends, showing the component of dip slip. The maximum sinistral offset was observed as the fault ran into the houses of Chihsing Street (site C1, Fig. 4d) next to the parking lot. The rupture passed in between the houses, inducing a maximum 77-cm-sinistral offset and at least 40-cm-uplift on the upthrown side (east of the fault trace), and consequently caused the tilt of the houses at site C2. The row of the tilted houses were pushed northwest, which

resulted in 80-cm-compression in front of the houses (site C2-front; point 15; Fig. 4e). The preliminary report from CGS (2018) estimated the amount of vertical offset to be 80 cm according to the shortening features. However, we suspect that the vertical slip in this area should be smaller as we can trace the rupture from C1 all the way through the back of the houses (site C2-back; point 565) and an apparent 27-cm-uplift of the floor base was recorded at one of the tilted houses when the repairing team attempted to excavate the base of the tilted building and lift the floor back to level with arrays of hydraulic lifting jacks. The thrust surface rupture lifted the rear corner of the house and caused the front corner of the building to push against the tarred road, resulting prominent compressional damage along the front of the houses. The net vertical offset near site C2 therefore should be in the range of 20 (max. amount at site A) to 40 (max. amount at site C1) cm and we identified the 80-cm-compression as the category 3 damage which is not directly referred as the surface rupture (Fig. 3a).

As the fault extended southwest into the hill of Mt. Chihsing, the revetment was damaged and showed an opening of over 40 cm along the fault trace (site D). The rupture remained N60°E-striking and displayed an offset of 70-cm-sinistral at the margin of the hiking trail (site E1, Fig. 4f) and at least 30 cm of compression at the trail nearby (site E2, Fig. 4g) before it passed through the Chihsingtang Bridge. The southern end of the bridge was severely damaged with disrupted concrete blocks moving along the sheared senses (site F, Fig. 4h) and at least 70 cm of sinistral offset was estimated by CGS (2018).

Fig. 4. Field photos of the representative ruptures. (a) Offset wheel track on the gravel beach. (b) Uplifted scarp on the beach. (c) Drone image of the Chihsingtan Parking Lot, showing a series of Riedel shears and en-echelon folding. (d) Surface rupture that ran across the houses and caused sinistral and reverse offsets. (e) Compression along the tarred road and the tilted porch pushing forward against the road. (f) 70-cm-sinistral offset passed through the hiking trail. (g) Sinistral offset ran across the trail and continued to the road below. (h) Drone image over the Chihsingtan Bridge showing massive ruptures on the bridge.

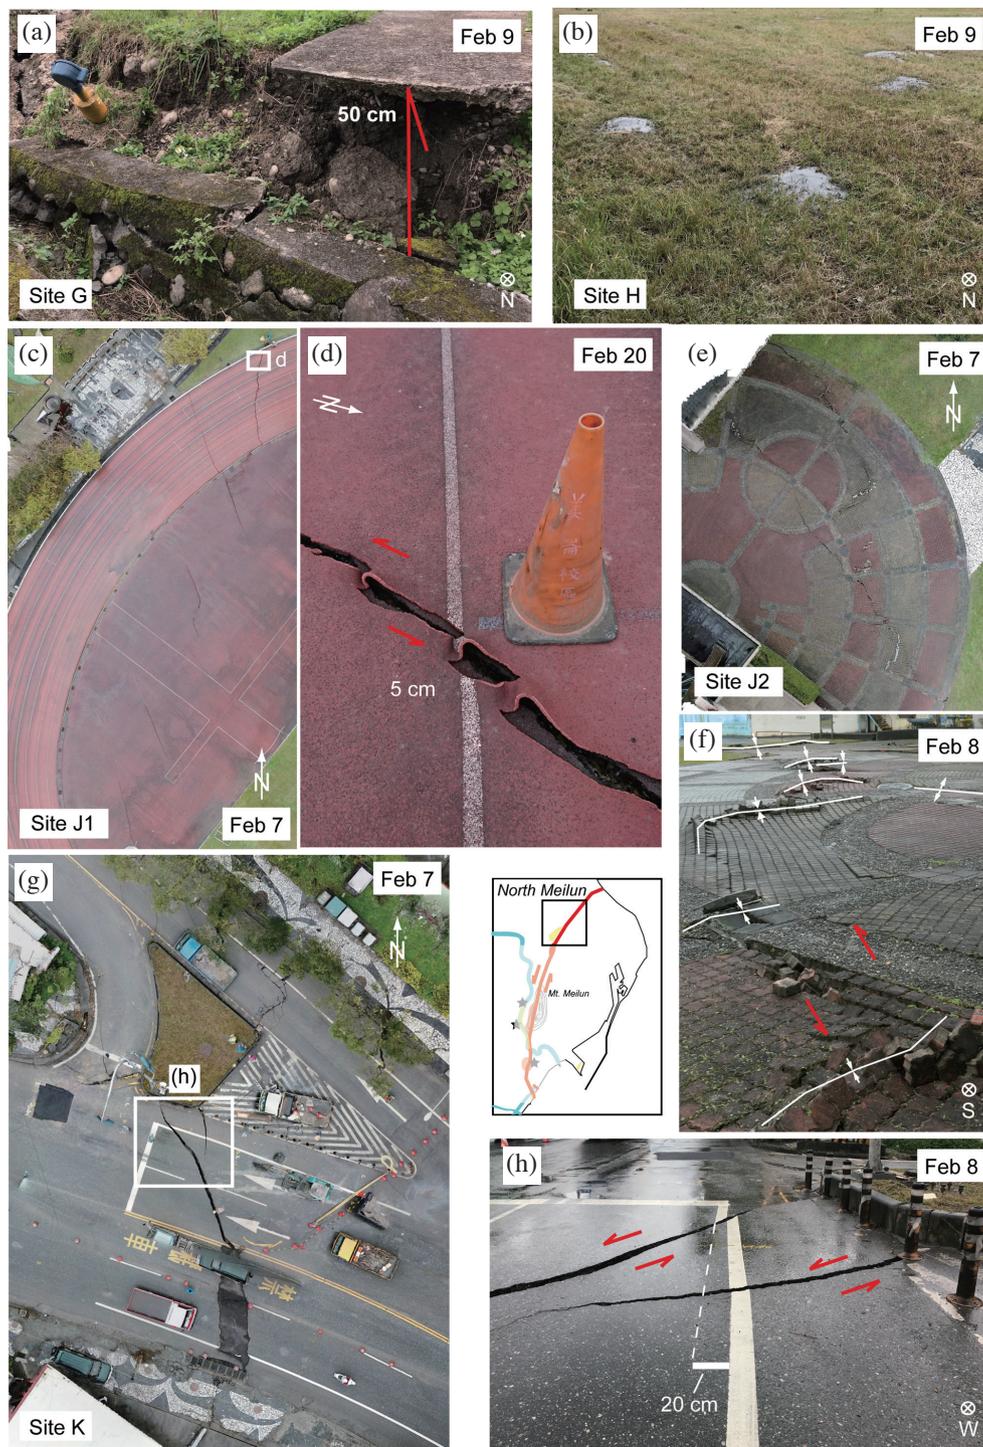
Fig. 5. Field photos of the representative ruptures. (a) Uplifted pavement. (b) Liquefaction features in area of site H. (c) Drone image over the track field of the campus, NDHU, showing a series of Riedel shears. (d) One of the shears showed a 7-cm-sinistral offset. (e) Drone image over the Meilun campus of NDHU, showing the development of shears and restraining bends. (f) Close-up of the push-up moletracks that connected the shears. (g) Drone image showing the multiple offsets south of the NDHU Meilun campus. (h) The road mark was offset about 20 cm in total.

tensional fissures (Figs. 5e and f). Compared with J1, the surface deformation zone at J2 was more continuous and possibly reflected the strength of overlying material as the brick tiles were easier to disrupt than the polyurethane running tracks. Most of the deformation at J2 was accommodated as push-up features and thus added more uncertainties on the estimated amount of offsets. Hsu et al. (2018) have evaluated the total amount of surface offset at J2 to be around 15 cm sinistral.

The two segments converged back to one as the fault trace extended towards south and disrupted the roads south of the campus (site K, Figs. 5g and h). On-site measurement and RTK GPS survey of the damaged tarred roads showed clear sinistral displacement of 20 - 30 cm. It is to note that the amount of vertical offset has significantly waned from south of sites I to K.

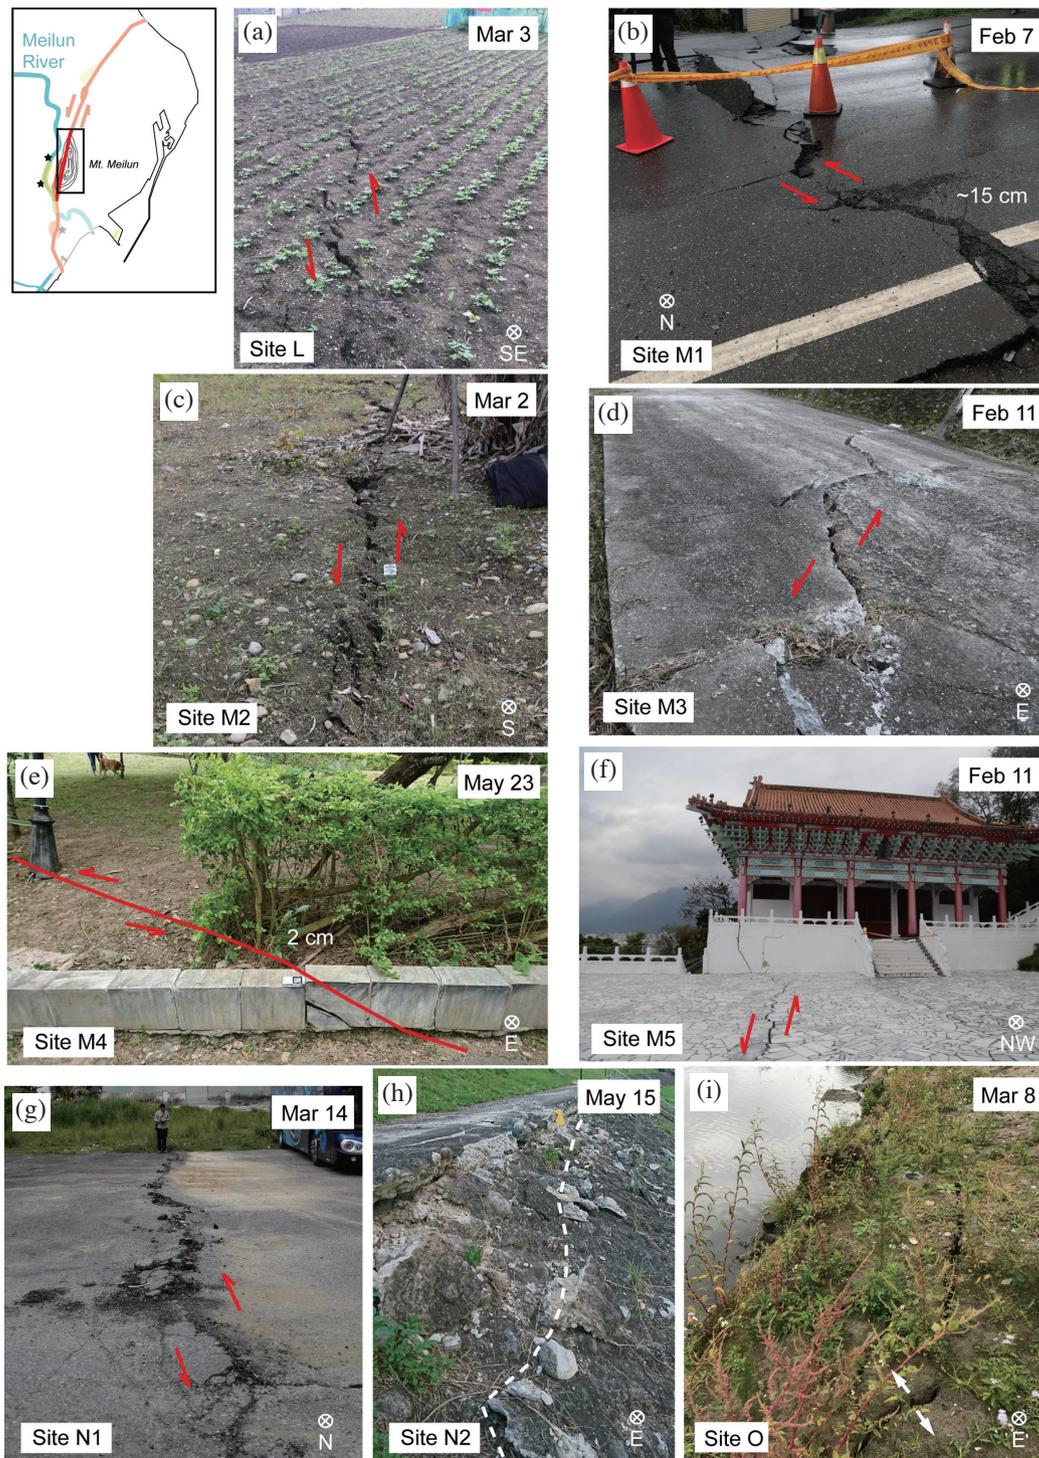
The trace of earthquake faulting can be tracked further south with a general strike of $N24^\circ E$ until the hill of Mt. Meilun. At site L (Fig. 6), sinistral cracks with max. 6-cm-tension occurred on the peanut field and extended southward as en-echelon arrays (Fig. 7a). These tensional shears generally arrested in short length (ca. 2 - 18 m) and the amount of sinistral offset is not significant on each trace. CGS estimated the total sinistral offset here to be more than 30 cm according to the disrupted ditch nearby (CGS 2018).

The rupture appeared on the west flank of Mt. Meilun at the intersection of Shangzhi Rd. and Xinxing St. and produced a max. 15-cm-sinistral offset with S-shaped moletracks on the tarred road (site M1, Fig. 7b). The surface damage can be traced southward as a series of northwest-striking en-echelon tensional shears on the bare ground of a banana field within a total length of ca. 90 m (site M2, Fig. 7c). Most of the tensional shears were about 2 m long (max. 20 m) and displayed opening of 1 - 20 cm. The fault trace ran across the Shangzhi Water Purification Plant and extended southward to the hillside of Mt. Meilun (site M3, Fig. 7d). The rupture can be continuously traced until the southern tip of Mt. Meilun. At site M4 (Fig. 7e), the surface rupture cut through a meadow, causing the tilt of streetlight pole, the toppling of the bushes, and an offset of 2-cm-sinistral of the pavement bricks. Prolonged surface deformation such as tensional fissures and Riedel shears can be observed across the Martyrs' Shrine (site M5, Fig. 7f).

Fig. 7. Field photos of the representative ruptures. (a) En-echelon cracks on the peanut field. (b) The road mark was ruptured about 15 cm with S-shaped moletracks. (c) En-echelon cracks on the banana field. (d) Sinistral offset on the concrete road of Shanzhi Water Purification Plant. (e) Sinistral offset passed through the streetlight, bushes, and the bricks, causing the toppling of the bush and the bricks. (f) Sinistral shears ran across the Martyr's Shrine. (g) S-shaped moletracks with sinistral component passed through the parking lot of site N1. (h) The revetment was continuously damaged along the north bank of Meilun River. (i) Surface cracks parallel to the river occurred along the south bank of Meilun River.

along the gutters and the field (site N1, Fig. 7g). Pull-apart depressions occurred locally with up to 50 cm subsidence and appeared to be related to poor compaction of foundations rather than tectonic offset. The surface deformation extended to the north bank of the Meilun River and resulted in significant damage on the embankment (site N2, Fig. 7h) in the forms of sinistral and dextral shears, push-up ridges, and collapse of dike walls and pavements. The south bank of the river featured a great number of liquefaction features and tensional cracks (site O, Fig. 7i). However, these surface openings mostly were parallel to the river course and appeared to be rather related to the slumping of river bank deposits. In general, site O comprised very few infrastructure damage when compared with the north bank, reflecting its poor connections with PDZ. The main rupture ran through site M and extended to the north end of the Shanzhi Bridge before passed the Meilun River.

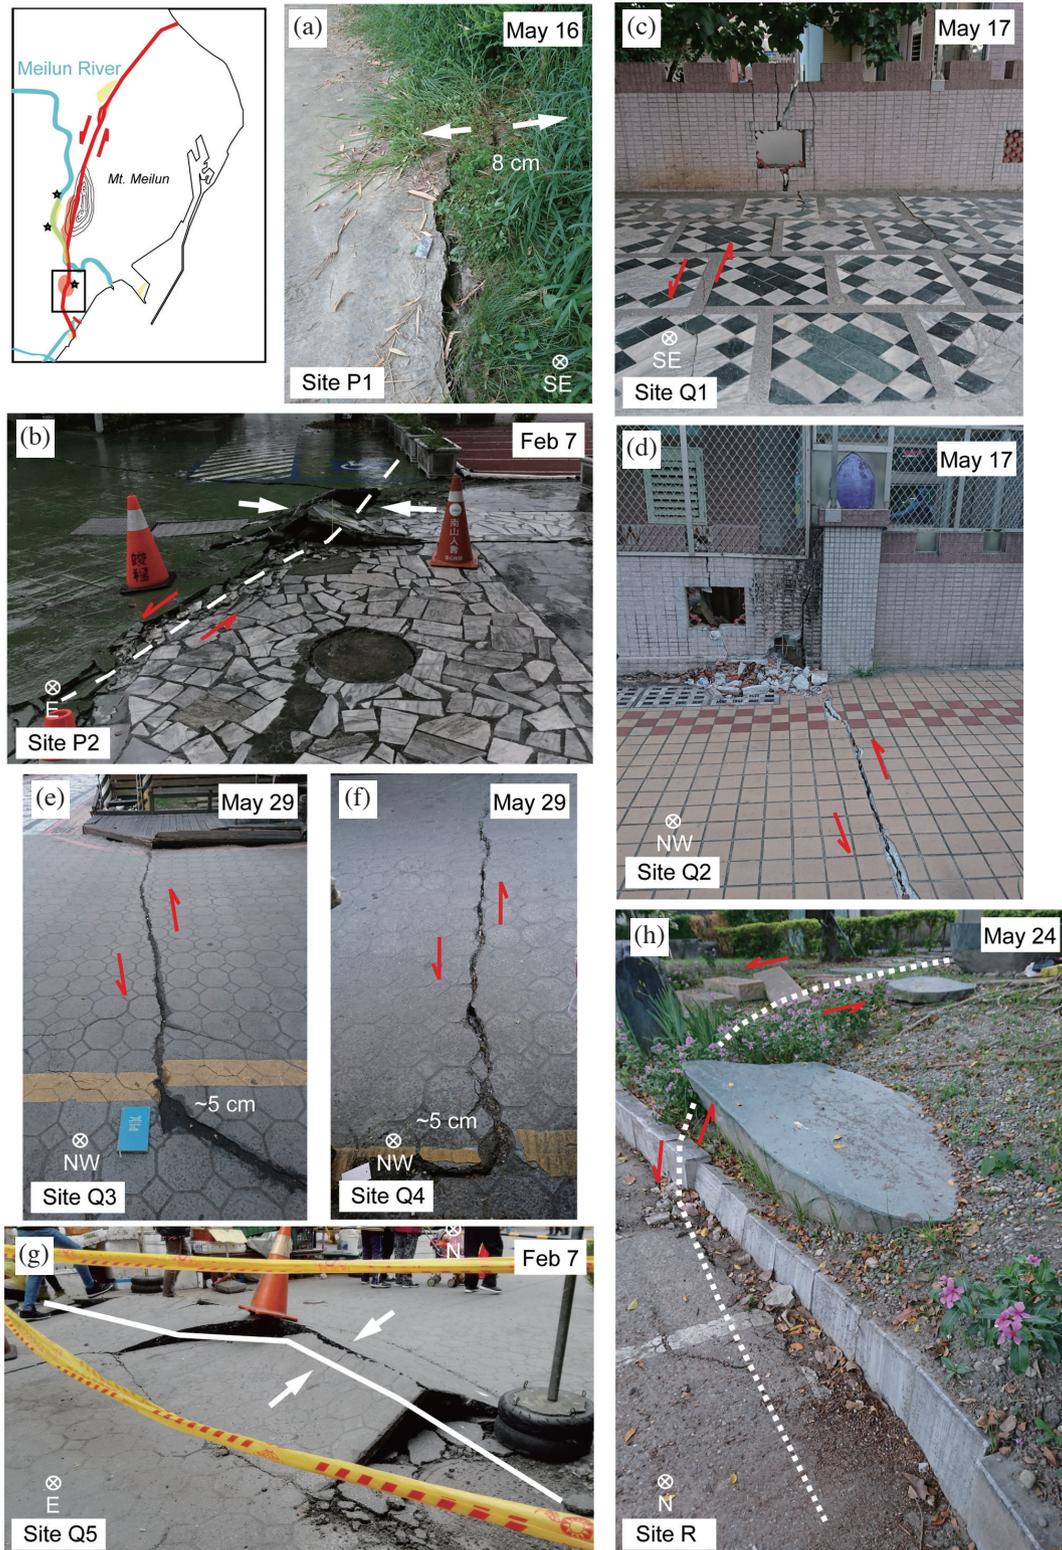
The ruptures extended into the downtown area and displayed a more complex distribution (Figs. 8a and b). At the south bank of Meilun River, the rupture occurred as tensional cracks north of the Mingli elementary school (site P1, Fig. 9a) and generated northwest-striking shears and a prominent E-W striking push-up ridge inside the campus (site P2, Fig. 9b). The surface rupture passed through the campus and extended south into the city. The ruptures in the downtown area were no longer restricted in a width of couple meters as in the north segments. Instead, a series of northwest-striking ruptures occurred in a broad width of ca. 270 m as an array of fully or partially overlapping lineaments (sites Q to S). These ruptures caused continuous damage on the buildings, roads, and infrastructures and can be tracked easily. For instance, sites Q1 and Q2 clearly displayed the occurrence of PDZ, breaking through the front (Fig. 9c) and back (Fig. 9d) doors of a kindergarten. The amount of offset near Q1 was measured from the shifted poles on the street with RTK GPS to be around 10-cm-sinistral. Sites Q3 and Q4 both presented 5-cm-sinistral offsets (Figs. 9e and f). Push-up ridges also occurred at site Q5 (Fig. 9g) with a northeast strike and a compressional amount of around 10 cm. The cumulative amount of total offsets in the area of site Q thus were estimated as 10 - 15 cm.

The surface ruptures passed through site R and resulted in the toppling of stone plates and pavement bricks (Fig. 9h). Distributed offsets were also recorded at site S where several prolonged sinistral ruptures occurred across the Hualien Railway Culture Park Hall 2 (site S1, Fig. 10a) and Hall 1 (site S2, Fig. 10b). The PDZ advanced further south from Hall 2, producing multiple rupture lines with ~10-cm-sinistral offset at site T1 (Fig. 10c) and generated a series of northwest-striking en-echelon tensional shears connected by northeast-striking push-up moletracks on the

Fig. 9. Field photos of the representative ruptures. (a) Tensional cracks occurred north of the Mingli elementary school. (b) Push-up ridge and shears in the campus of Mingli elementary school. (c) Sinistral offset ran across the front door of the kindergarten. (d) Sinistral offset ran out from the back door of the kindergarten. (e) Sinistral offset of ca. 5 cm occurred at site Q3. (f) Sinistral offset of ca. 5 cm occurred at site Q4. (g) Push-up ridge occurred at site Q5. (h) Sinistral rupture offset the stone plate and the pavement bricks.

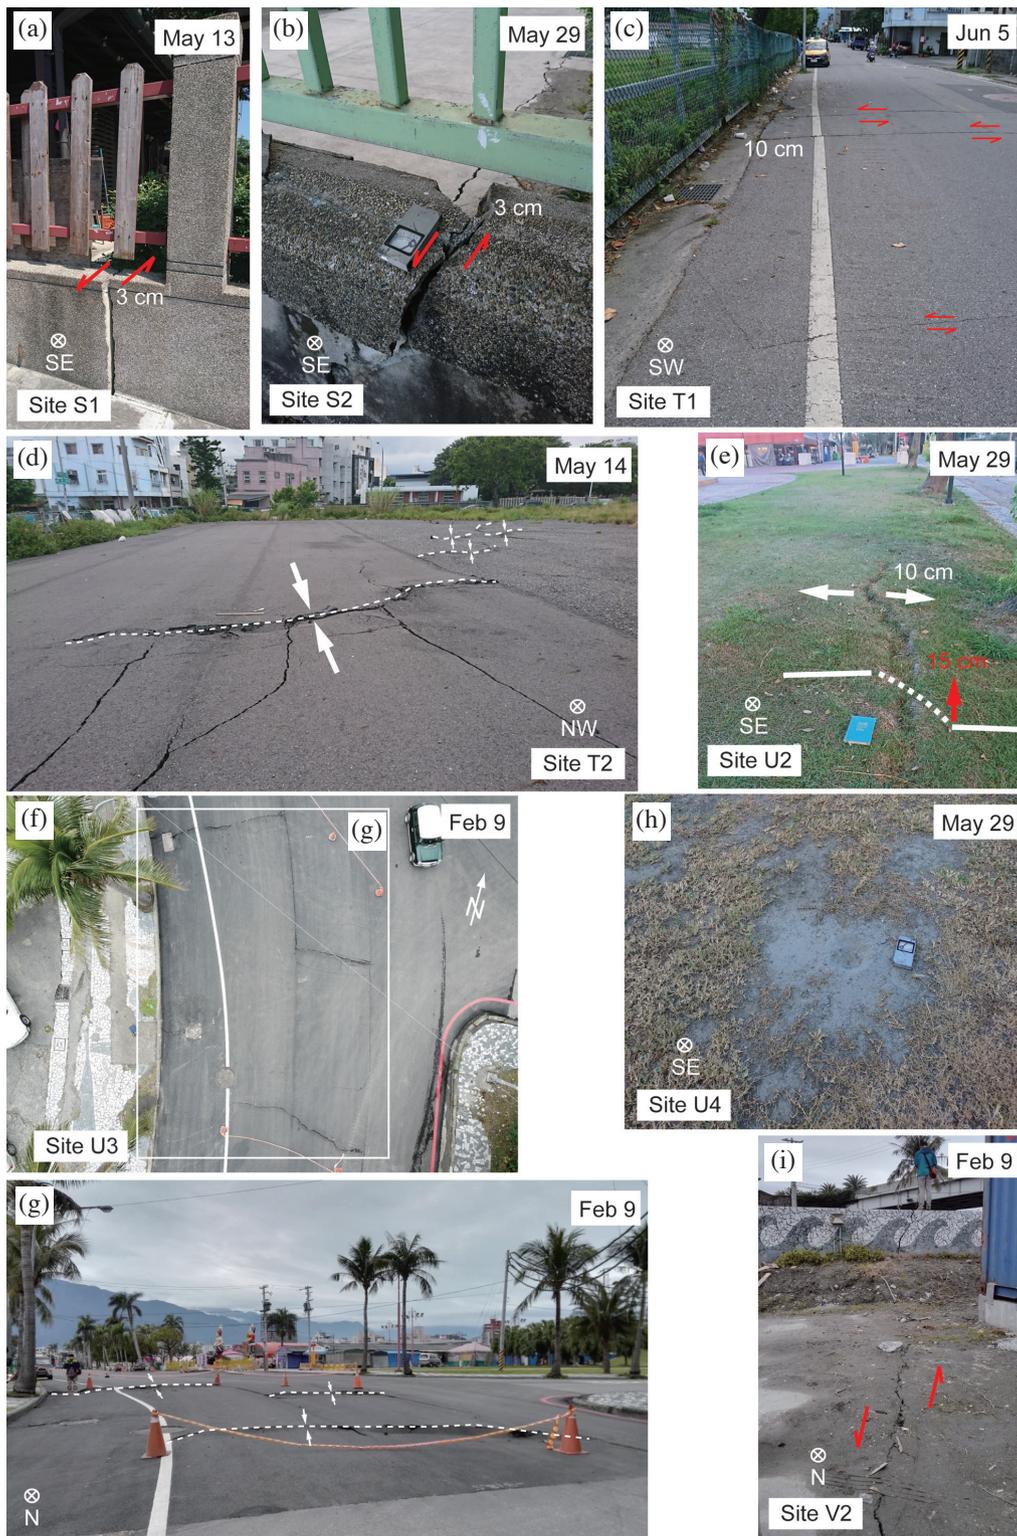
tarred field (site T2, Fig. 10d). The rupture zone can be continuously tracked across the street into the night market area with prominent tensional cracks and a gentle scarp of ~15 cm uplift (e.g., site U2, Fig. 10e), a series of push-up ridges and en-echelon fissures (e.g., site U3, Figs. 10f and g), and occasionally liquefaction features (site U4, Fig. 10h).

Fig. 10. Field photos of the representative ruptures. (a) The guardrail of the Hualien Railway Culture Park Hall 2 was offset about 3 cm. (b) The guardrail of the Hualien Railway Culture Park Hall 1 was offset about 3 cm. (c) The road mark was offset about 10 cm in total. (d) A series of push-up moletracks connected the northwest-striking shears. (e) Surface cracks aside the night market. (f) Drone image of the push-up ridges in front of the night market. (g) Close-up of push-up ridges at site U3. (h) Sand boils on the ground showing the features of liquefaction. (i) Sinistral ruptures ran across the stone wall and the ground surface in the yard of the Funeral Parlour.

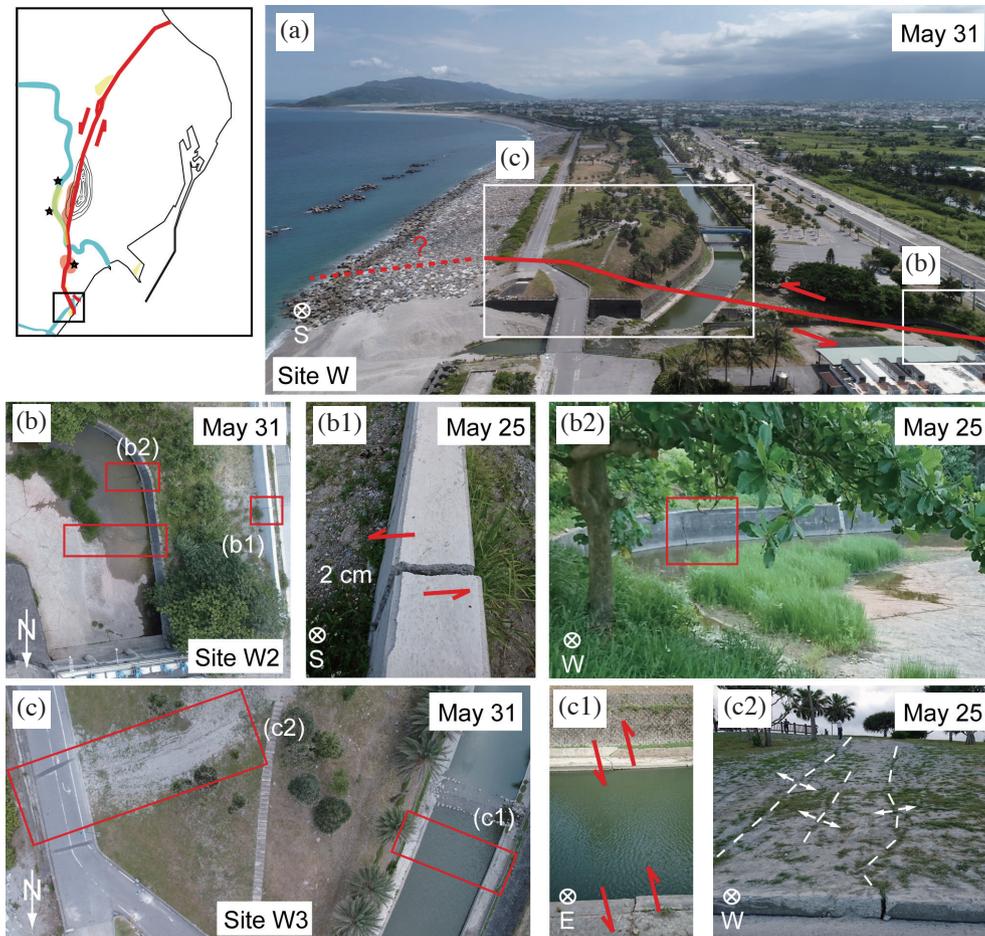
The PDZ marched forward south with two rupture zones: the minor one occurred to the southeast of the night market and generated several prolonged ruptures that cut across the street and the Funeral Parlour before extending into the coastal line (site V2, Fig. 10i). The major one advanced southward directly (site W, Fig. 11a) and broke through the Water Pumping Station (site W2, Fig. 11b) and the channel (site W3, Fig. 11c). At site W2, the rupture produced 3-cm-sinistral offset on the concrete wall (Fig. 11b1) and opened at least two fissures on the revetment of the Water Pumping Station (Fig. 11b2). The ruptures proceeded toward the coast, passing through the artificial channel (Fig. 11c1) and caused several tensional cracks on the surface of the hillslope (Fig. 11c2). The surface ruptures continued across the tarred trail and then became obscured on the gravel beach.

Fig. 11. Field photos of the representative ruptures. (a) Drone image showing the relative location of the south end. (b) The rupture passed through the Water Pumping Station from west to east. (b1) Rupture extended from north broke through the concrete wall. (b2) The wall of the revetment were damaged with tensional cracks. (c) Drone image showing the extension of the ruptures. (c1) The rupture passed through the channel from west to east. (c2) Prolonged en-echelon cracks occurred on the hillslope.

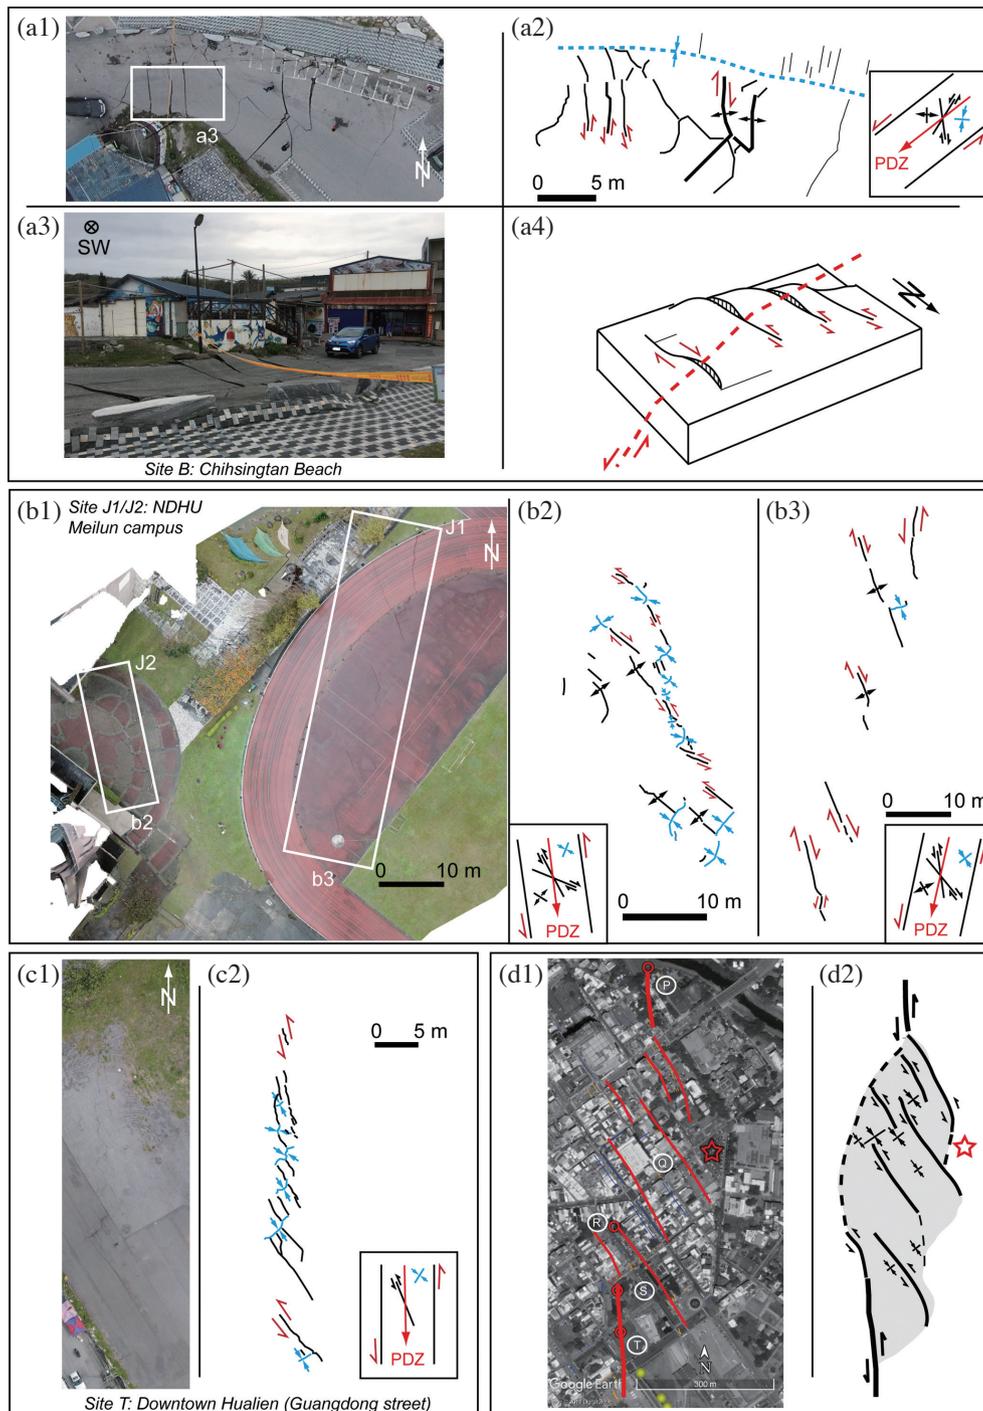
South of Chihsingtan Beach, most of the ruptures developed as en-echelon arranged synthetic Riedel shears with tensional components and were connected by synthetic push-up moletracks or ridges. Antithetic Riedel shears occurred sometimes with comparable or smaller amount of dextral offsets that accommodated the moving sense of deformed blocks. The bifurcated segments at sites J1 and J2 showed two typical geometry of surface ruptures associated with the Milun Fault (Fig. 12b1): at J1 (Fig. 12b3), the fault ruptured as offset, separation, or partially overlapped segments with NS-striking sinistral or northwest-striking dextral shears (description of step-over geometry follows; Barka and Kadinsky-Cade 1988; Mitra and Paul 2011; Fig. 2c). At J2 (Fig. 12b2), northwest-striking Riedel shears of right- or left-lateral sense both occurred. Hard links between the segments developed as the northeast-striking push-up moletracks, forming gentle and sharp restraining bends. Down to the south, site T (Fig. 12c1) provided another example showing a series of synthetic Riedel shears propagated southward and the restraining bends consequently developed (Fig. 12c2).

In downtown Hualien, an array of northwest-striking ruptures formed a prominent linking damage zone with right stepping step-overs fully or partially overlapped with each other and accompanied by some minor northeast-striking push-up ridges (Figs. 12d1 and d2). The ruptures did not evolve into through-going lineaments and hence resulted in relative wider restraining areas between the step-overs (Wakabayashi et al. 2004; Cunningham and Mann 2007). Field observation of continuous damage along the pavements, arcades, and floors of houses demonstrated the existence of transpression zones. However, as the separation zone between the fault tips is relative small, an alternative explanation of these widely-spread shears is that these deformation may correspond to an earlier stage of rupture propagation within the downtown where the surface is densely covered by the concrete and steel buildings (Riedel 1929; Davis et al. 2000, 2011). Nevertheless, as the buildings and

Fig. 12. Photos and illustrations showing the representative structures occurred along the rupture zones. (a1) Drone image of the Chihsingtan Parking Lot. (a2) Schematic illustration of the associated ruptures. Inset shows the conceptual setting of the stress field. (a3) Field photo of the surface deformation. (a4) Schematic diagram of the en-echelon folding. (b1) Drone image of the Meilun campus, NDHU. (b2) Schematic illustration of the rupture lines in front of the gym. (b3) Schematic illustration of the rupture lines in the track field. (c1) Drone image of the Guangdong Street field at site T. (c2) Schematic illustration of the rupture lines in the field. (d1) Close-up of the major ruptures in downtown area from sites P to T. (d2) Schematic illustration of the rupture lines showing the arrangement of right stepping step-overs and a wide zone of transpression across the downtown.

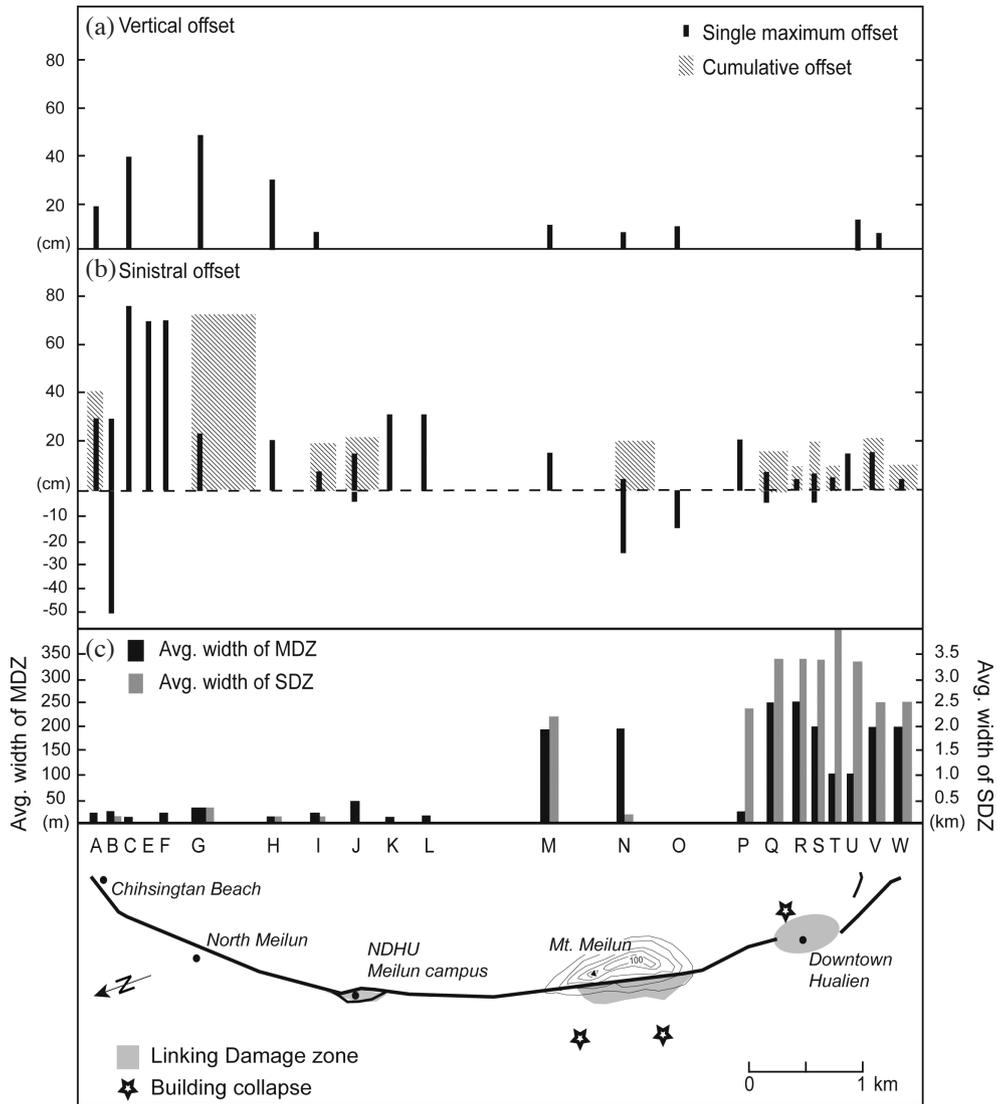
The orientation, amount of offsets, and the width of damaged areas across the fault trace all appeared to vary from north to south (Fig. 13, relevant records are listed in Table 1). The strike of the fault evolved counter-clockwise from northeast to northwest and formed a curved trace concave to the east. The maximum vertical displacement was measured as 50 cm on the north segments (site G) and the amount of vertical offset decreased to almost undetectable toward south. Horizontal displacement showed a similar trend with a maximum sinistral offset of 77 cm occurred in the north end of the fault (site C) and the averaged sinistral offsets decreased from 57 cm in the north to 15 cm in the south.

According to the category of investigated damage points, we have estimated the width of MDZ and SDZ. The width of MDZ represents how far the slip of a fault can be accommodated and the width of SDZ represents how far the impact of ground motion can persist from the fault core area. The width of MDZ was mostly very limited within the range of 1 - 20 m along the wall damage zones on the northern part of the fault except for site J (up to 80 m) where bifurcated segments occurred, developing prominent step-overs and restraining bends. In areas of the linking damage zones, the width of MDZ increased as the slip appeared to be distributed across a much wider area along the discontinued segments. In downtown Hualien the width can even reach 270 m wide, denoting the broad range of the damage zone. Similarly to MDZ, the width of the SDZ significantly increased from tens of meters in the north to 2 - 4 km in the central to south part of the fault.

In general, the amount of offset decreases toward south while the width of damage zone increases. The vertical displacement is larger in the north and becomes insignificant in the south part of the fault. Similarly, the sinistral displacement is large and localized in the north and decreases to the south with a broad range of distributed slip.

Fig. 13. The distribution and characteristics of offsets along the fault. (a) The vertical offset along the fault. (b) The sinistral offset along the fault. Note that dextral offsets are drawn as negative values. Cumulative offsets are presented as areas of slant lines in sites with distributed offsets. (c) The average width of MDZ and SDZ across the fault.

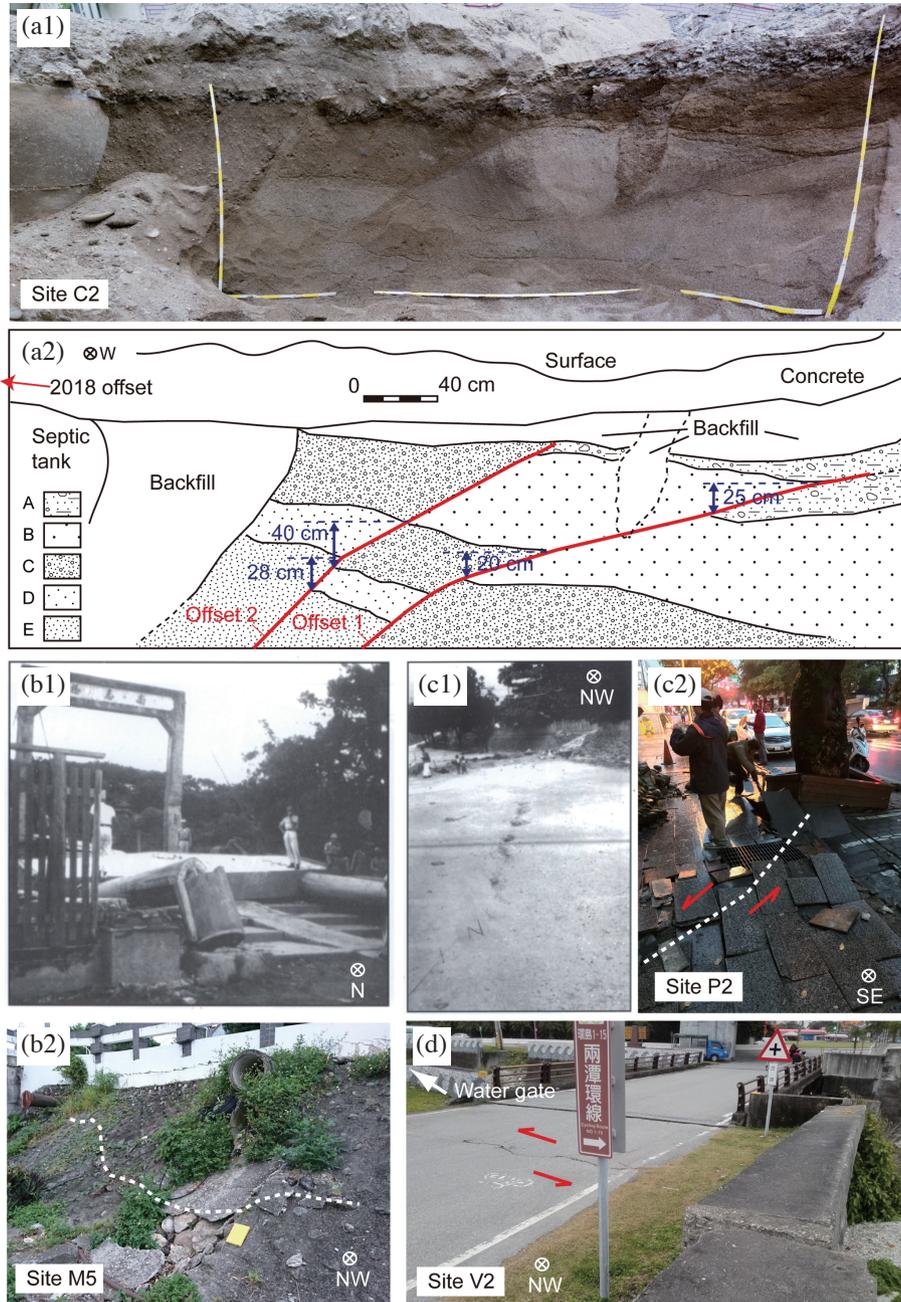
At the Chihsingtan area, an excavation near the damaged house was operated to repair the floor of the house (near site C2, excavation location is labelled in Figs. 3a and 4e) and hence revealed the earlier events of offset (Figs. 14a1 and a2). Five major strata and two faults were identified below the concrete floor and the backfill

Fig.14. (a1) The photo of the excavation beside the damaged house at the Chihsingtan Area. (a2) Schematic illustration of the offset strata. (b1) Historic photo showing the damage at the north end of Shangzhi Bridge. (b2) Damaged revetment below the north end of Shangzhi Bridge. (c1) The northwest-striking cracks occurred on the road by the elementary school. (c2) Disrupted tiles by the elementary school. (d) Sinistral offsets near the Nanbin Water Gate.

layers. The uppermost unit A is composed of brown coarse sand and very fine gravel with some lamination. Below that, the unit B comprises massive white sand to coarse sand with coarsening upward grading. The underlying unit C is poorly sorted, comprising yellow to brown fine sand to sand with occasional occurrence of pebble size clasts. Unit D is composed of white coarse sand with fining upward grading. The lowermost unit E comprises well-sorted yellow sand and occurs as a massive unit. The two offset planes cut through the five units and display vertical offsets of 20 - 40 cm. The offset 1 displays a vertical displacement of 25 cm between A and B units, and 20 cm between B and C units; the offset 2 displays a vertical displacement of 40 cm between C and D units, and 28 cm between D and E units.

Both of the offsets did not reach the surface nor the backfill, indicating that these vertical displacements occurred prior to the 2018 earthquake. In addition, the back-filled V shaped burrow penetrated unit C and even cut across the plane of offset 1, suggesting that the digging of the burrow post-dated the offset. The two offsets did not rupture during the 2018 earthquake and the coseismic rupture of the 2018 earthquake occurred at the rear corner of the house, recording an uplift of ~27 cm as mentioned in section 3.1. The two offset planes in the excavation may either represent two individual events or a synchronous movement with two rupture segments. The apparent cut-through relationships of the preserved stratigraphy cannot distinguish the two scenarios and therefore suggest at least one earlier event in this location. Although offsets of the 1951 earthquake have been previously reported in the Chihshintan area, there was no exact information about where the damaged house and offsets really located. The stratigraphic profile from this excavation site clearly demonstrates the records of repeated ruptures in the Chihshintan area. The offset pattern inside the excavation is consistent with the 2018 earthquake, showing the east side of the fault to be the upthrown block and the occurrence of these vertical displacements validates the contribution of the Milun Fault upon the formation of local topography for the north Hualien.

dent surface ruptures were reported in 1951 as well. According to the report (Cheng et al. 1999), the 1951 earthquake produced en-echelon tensional cracks along the road by the elementary school (Fig. 14c1). After the 2018 earthquake, significant ruptures with sinistral slip also occurred and disrupted the paved tiles (Fig. 14c2). Although we do not have the exact coordinates of the 1951 ruptures, the orientation of the tensional cracks (N10°W on the road and N40°W inside the school; Cheng et al. 1999) are consistent with the 2018 earthquake (N20 - 50°W).

In 1951, newspapers and reports have documented that the south end of the fault passed through the Nanbin Water Gate, causing the embankment to collapse, and terminated its on-land rupture (Cheng et al. 1999). The embankment is now dismantled and hence the location of the Water Gate became ambiguous. There are two possible candidates for the location of the damaged Water Gate in 1951: the Water Pumping Station near Nanbin Park (site W) and to the east a lock gate currently called Nanbin Water Gate (site V). Judging from the relative position to the adjacent coastal line, site V may more likely be the one that has experienced repeated ruptures (Fig. 14d).
