# Mapping surface breakages of the 2018 Hualien earthquake by using UAS photogrammetry

Lin, Y.-S., R. Y. Chuang, J.-Y. Yen, Y.-C. Chen, Y.-T. Kuo, B.-L. Wu, S.-Y. Huang, and C.-J. Yang, 2019: Mapping surface breakages of the 2018 Hualien earthquake by using UAS photogrammetry. *Terr. Atmos. Ocean. Sci.*, 30, 351-366, doi: 10.3319/TAO.2018.12.09.02

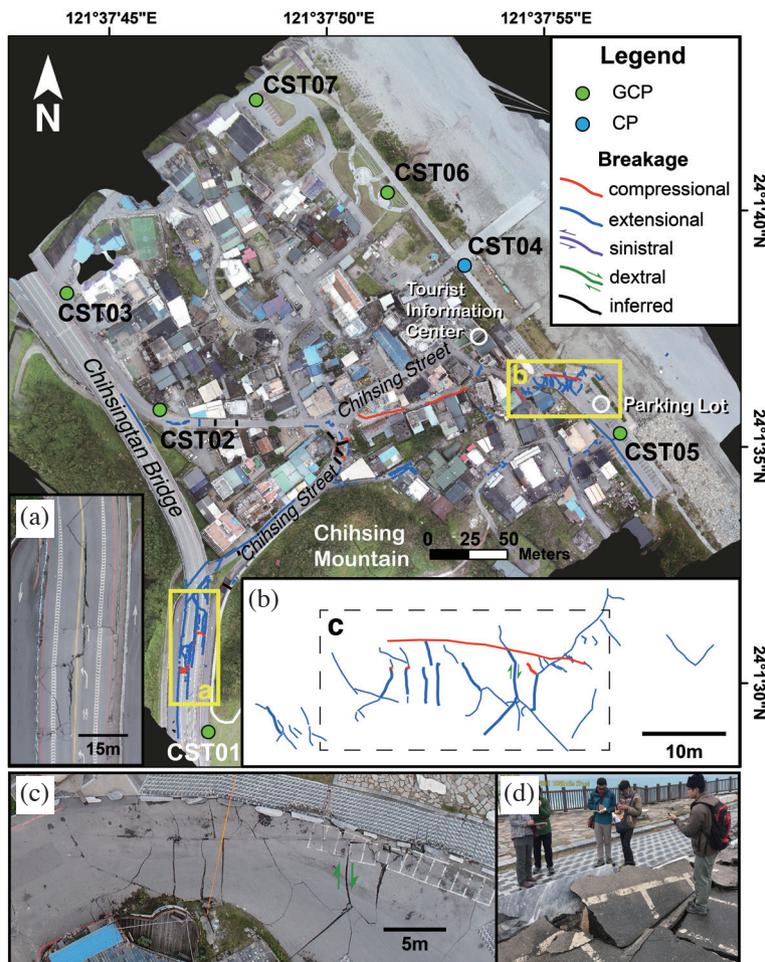
The northernmost surface ruptures begin from Chihsingtang and are concentrated along the northwestern edge of the Chihsing Mountain and surrounding terraces. Preliminary geologic investigations reported sinistral offset on the gravel beach (CGS 2018; ETEC 2018), which is not recognizable from the aerial images. Our mapped surface breakages generally follow the strike of N60 - 65°E and are distributed densely at the parking lot of the Chihsingtang Tourist Information Center, Chihsing Street, and the southern end of Chihsingtang (Fig. 2), which exactly fit the topographic front of Chihsing Mountain and surrounding terraces. At the parking lot, we mapped a series of parallel N-S striking fractures with sinistral slip and other oblique fractures (Figs. 2b, c, and d), possibly showing synthetic Riedel shears (R) and antithetic Riedel shears (R'). Uneven surface across these fractures shown in orthoimages and DSMs indicate vertical movement, but it is unclear to estimate total dip-slip offset because the vertical motion might be partially associated with slope failures as the fractures broke the coastal revetment, which is right north of the parking lot. Towards southwest, surface fractures show obvious compression along Lane 53 and become minor fractures along

Fig. 2. Mapping of surface breakages in Chihshintan. Green points are GPCs and blue point is CP. Red, blue, purple, green, and black line denotes compression, extension, sinistral, dextral, and inferred surface breakages, respectively. The principles for mapping breakages are described in the text. (a) Aerial image of surface breakages on the Chihshintan Bridge. (b) Detailed mapping of surface fractures at the parking lot of the Chihshintan Tourist Information Center. (c) Aerial image of surface fractures of (b). (d) Field photo showing the compressional feature at the parking lot [the long red line in (b)].

Chihsing Street to the south. At Chihshingtan Bridge, distributed fractures are present on the road surface (Fig. 2a).

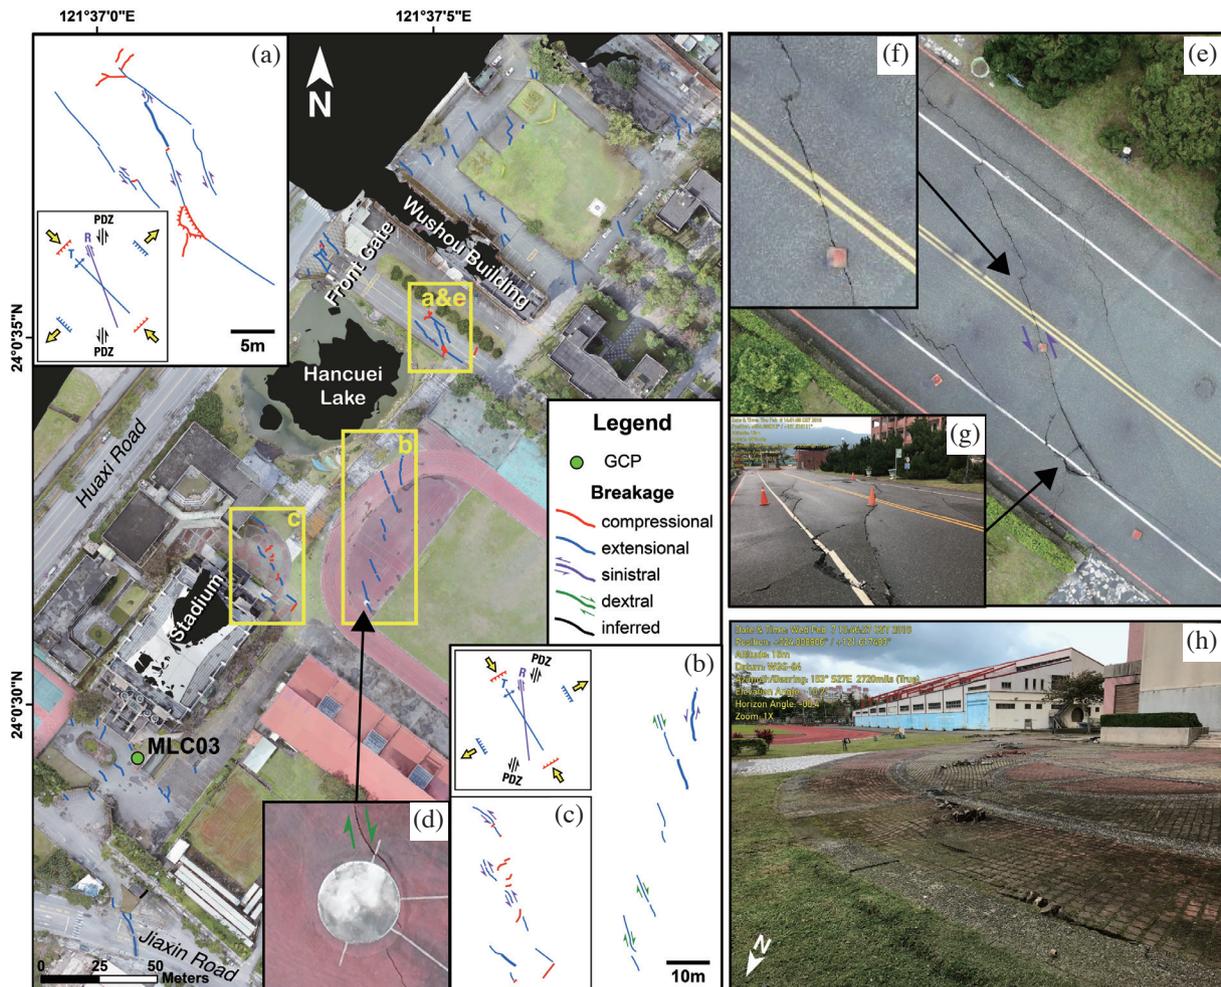
At the IRP, National Dong Hwa University, surface breakages ran across the western campus and bifurcated into two branches of fracture zones. Mapped fractures are more distributed at the northwestern campus and two fracture zones are identified surrounding Hancuei Lake toward south (Fig. 3). One branch ran across Wushou Building and connected to en échelon arrays on running tracks. Fractures south of Wushou Building are along  $\sim N25^\circ W$  with obvious left-lateral motion (Figs. 3a, e, f, and g). At the running tracks, the northernmost N-S striking fracture is subparallel to other fractures with sinistral motion while the rest fractures with the strike of  $\sim N23^\circ W$  demonstrate tension fea-

tures with some minor dextral movement (Figs. 3b and d). The first fracture can be interpreted as synthetic Riedel shear (R) and the latter are tension fractures (T), consistent with principal displacement zone (PDZ) in the direction of  $\sim N20^\circ E$ . The other branch broke the surface at the front gate of the campus and the brick pavement in front of the stadium (Fig. 3c). Fractures in front of the stadium are shorter and more compressional compared to those on the running tracks. The fractures here are dominated by push-up features as deformation is constrained by the shape and strength of the bricks. South of the stadium, the two fracture zones seem to join together and run across Jiaxin Road.

Fig. 3. Mapping of surface breakages in IRP, National Dong Hwa University. (a) Detailed mapping of surface fractures south of Wushou Building. Inset shows the conceptual setting of the stress field and structure orientations. (b) Detailed mapping of surface fractures on the running tracks. Inset shows the conceptual setting of the stress field and structure orientations. (c) Detailed mapping of surface fractures in front of the stadium. (d) Aerial image of fractures across the running tracks showing right lateral movement. (e) Aerial image of surface fractures south of Wushou Building. (f) Enlarged aerial image showing left-lateral movement across the solid double yellow line. (g) Field photo of (e). (h) Field photo of (c) showing compressed bricks.

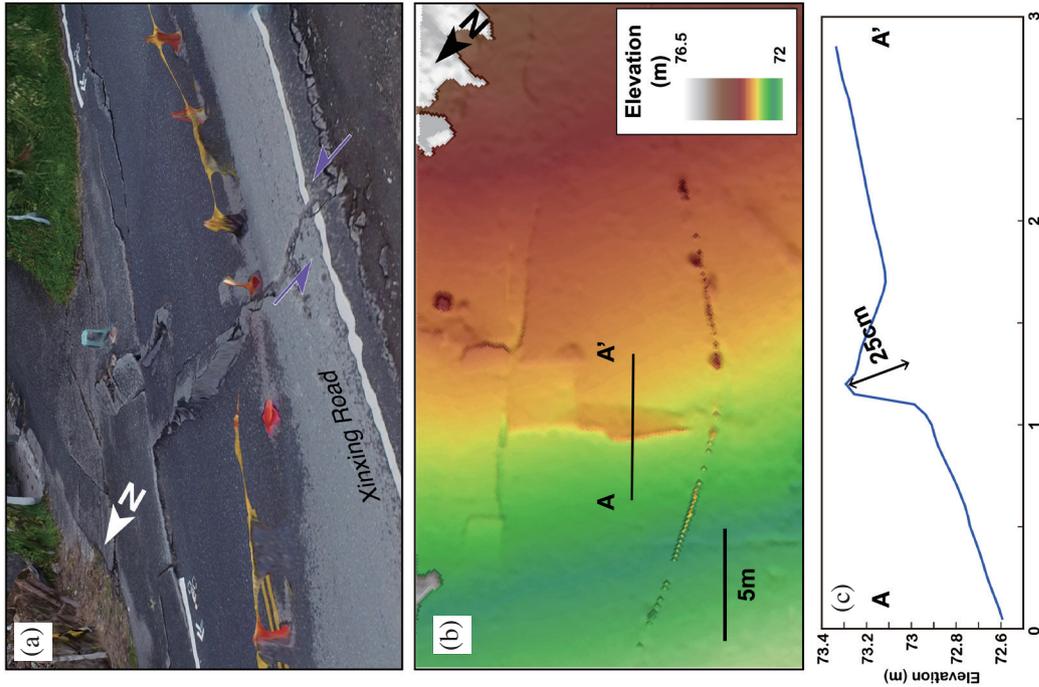
Fig. 5. 3D model of surface ruptures on XinXing Road in northern Meilun Mountain. (a) Oblique view of 3D model. (b) DSM of surface ruptures on XinXing Road. The elevation is WGS84 ellipsoidal height. (c) Topographic profile parallel to XinXing Road showing the geometry and height of the largest angular ridge.

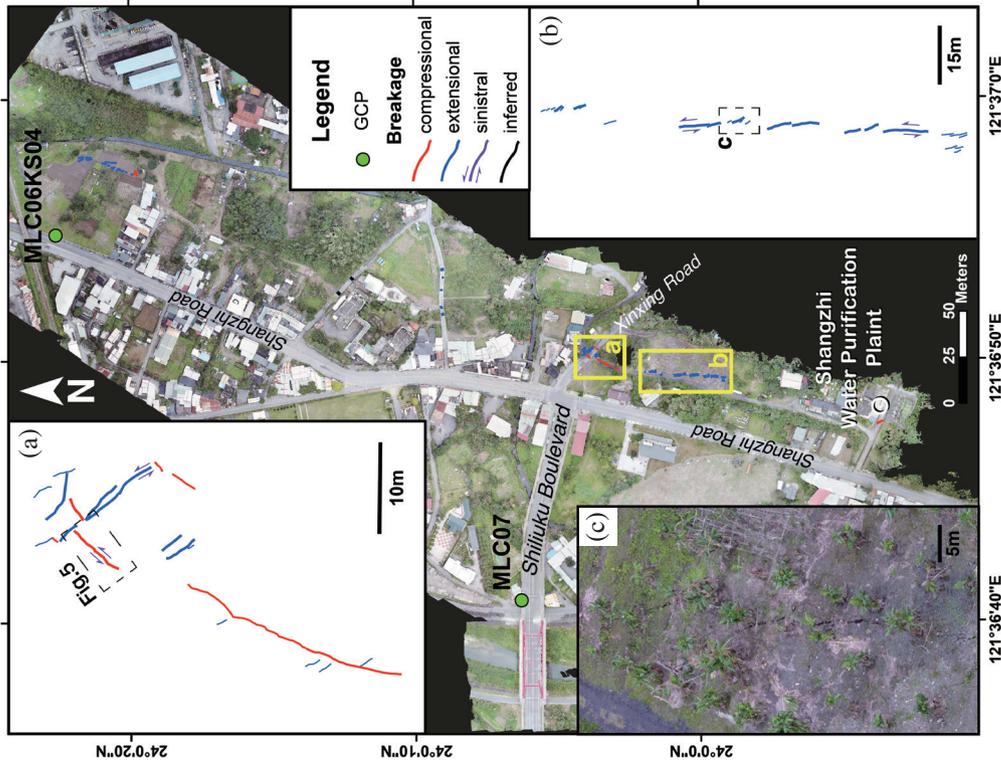
to Shangzhi Road with the strike of N20°E. South of Jiaxin Road, the fault trace is within orchards and groves so we only identified few fractures (Fig. 4). On XinXing Road around the northern tip of Meilun Mountain, the rupture transects the road with sinistral movement and push-up mole tracks (Fig. 4a). In addition to orthoimages, the SfM-MVS method generates 3D models and DSMs, showing topography and surface relief. According to the 3D model (Fig. 5a), the white side line to the south is offset sinistrally and the fractures across the road shows stepovers with features of angular ridges. DSM produced by the SfM-MVS method is also helpful for identify such features (Fig. 5b). A topographic profile estimates the height of 25 cm for the largest angular ridge (Fig. 5c). To the south note that the rupture climbed up to foothills instead of ran along the western boundary of Meilun Mountain. The strike of surface breakages become N-S striking tension fissures as going uphill to a banana orchard (Figs. 4b and c). Toward south, surface ruptures seem transect the Shangzhi Water Purification Plant, causing pipeline leakage and water outage for several days after the earthquake.

Fig. 4. Mapping of surface breakages in northern Meilun Mountain. (a) Detailed mapping of surface fractures on Xingxin Road. The box shows the location of Fig. 5. (b) Detailed mapping of surface fractures on the foothills of northern Meilun Mountain. (c) Aerial image showing N-S surface fractures across the banana field.

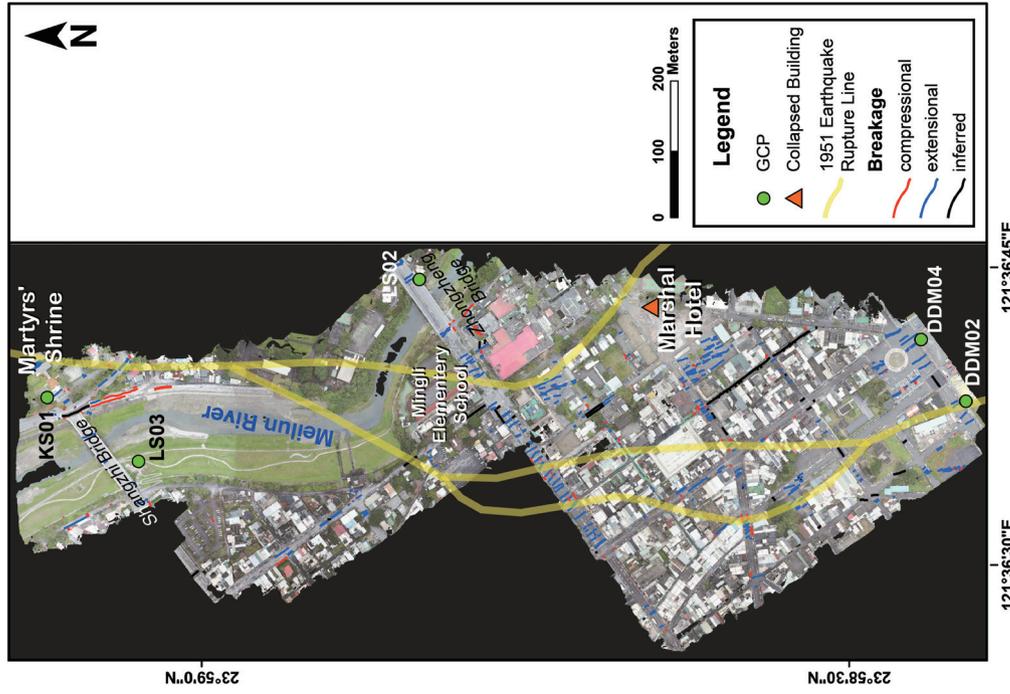
South of Meilun Mountain, surface fractures are extensively distributed across eastern downtown Hualien. Near the Martyr's shrine, fractures were present at both sides of Shangzhi Bridge (Fig. 7). The preliminary field investigations documented severe damages at the western side of

Shangzhi Bridge (CGS 2018); however, we failed to collect images at the place. Therefore, the fault trace could connect from the western edge of Meilun Mountain to the western side of Shangzhi Bridge. Further south, surface fractures seem to be restrained in between streets and open fields. Tensional shears were mapped mainly in the direction of N35°W and compression fractures generally follow the direction of N55°E (Fig. 7). Fractures at open fields like tarred fields west of the collapsed Marshal Hotel have a little bit more diverse and oblique orientations. Note that it is somewhat difficult to map surface fractures within such urban areas on the orthoimages, especially when fractures are present along the edges of buildings or under the verandas. Overall, surface fractures in eastern downtown Hualien display distributed patterns with restraints from surrounding buildings. Compared to the surface rupture lines of the October 1951 earthquake (CGS 2018), surface fractures of the 2018 Hualien earthquake in downtown Hualien City are more distributed (Fig. 7).

Fig. 7. Mapping of surface breakages in east of downtown Hualien. Light yellow lines are surface ruptures of the October 1951 earthquake modified from CGS (2018).

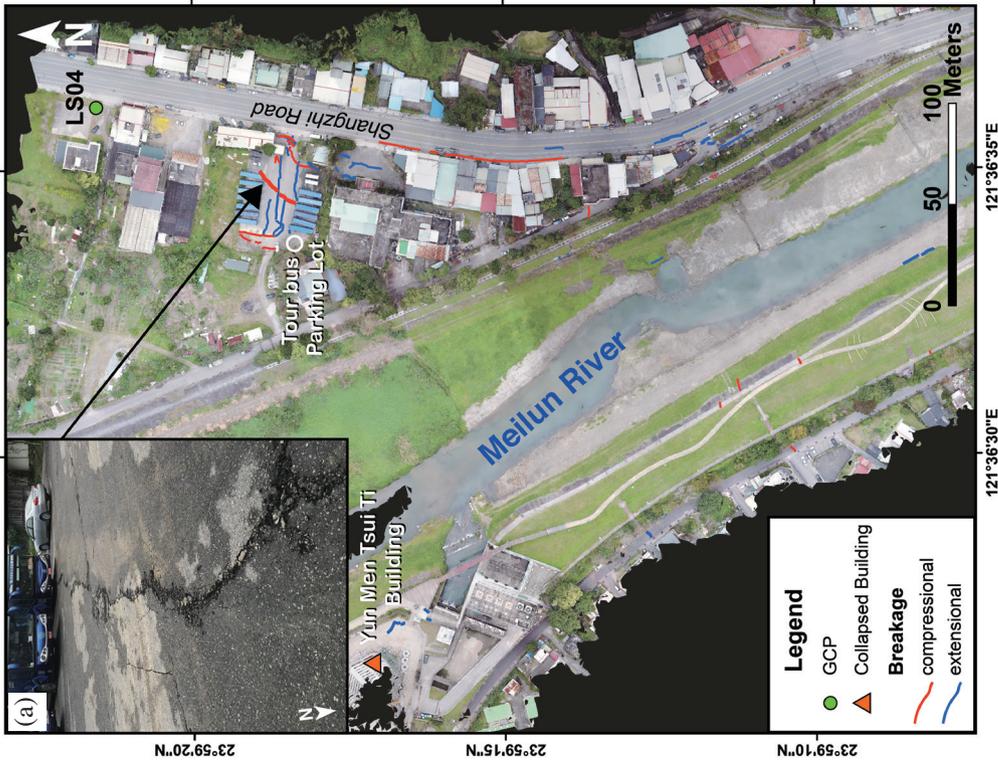
To the western edge of Meilun Mountain, surface breakages are present along the western side of Shangzhi Road. The surface fractures around northern Meilun Mountain seem to be vanished south of the Shangzhi Water Purification Plant in the hills, and at the same latitude to the west the surface fractures start to be present along the western edge of Meilun Mountain, suggesting a major stepover of surface ruptures. At the western tip of Meilun Mountain where Shangzhi Road alongside Meilun River, compression fractures mainly followed the western side of Shangzhi Road and crossed a tour bus parking lot (Fig. 6a). The orientations and types of surface breakages at the bus parking lot may result from its foundation strength instead of the fault movement. Since the rupture is within the foothills of northern Meilun Mountain (Fig. 4) and is along the edge of the mountain here, it seems that the fault trace steps down from the foothills to the foot of Meilun Mountain. In addition, because multiple fractures broke the both sides of Meilun River embankments (Fig. 6) and few surface breakages are found along the eastern side of the river south of this point (Fig. 7), it is plausible that the fault trace crossed the river around the western tip of Meilun Mountain.

Fig. 6. Mapping of surface breakages in western Meilun Mountain. The tilted building to the left is Yun Men Tsui Ti Building, one of the four buildings collapsed during the earthquake. (a) Field photo of the damaged tour bus parking lot.

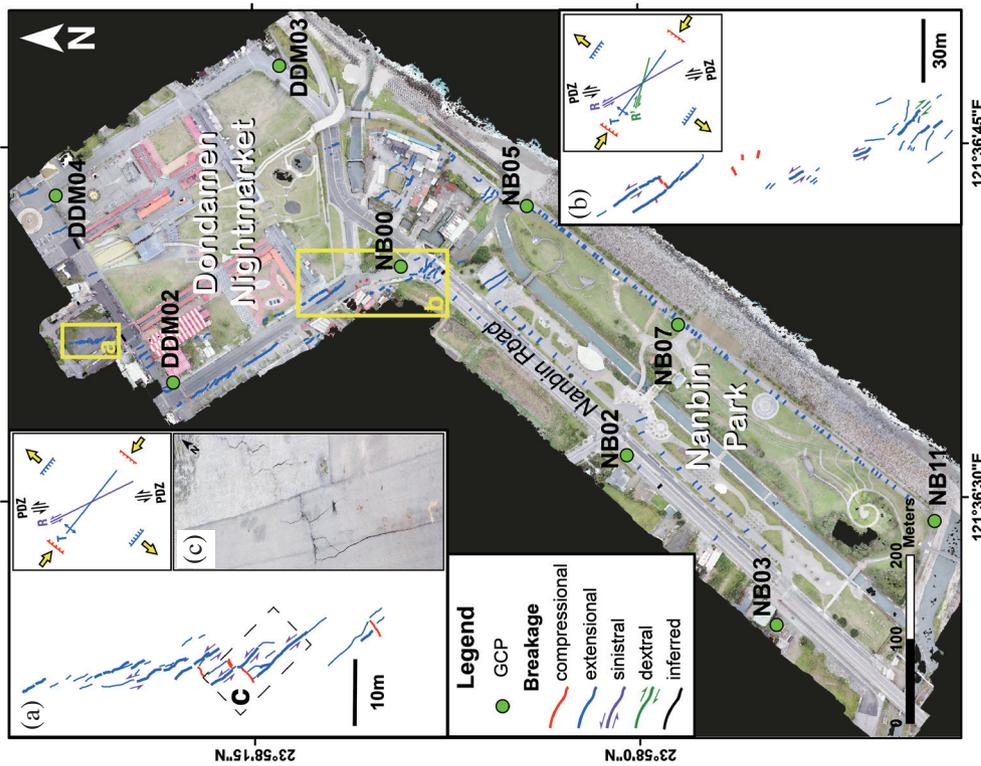
Towards southern Hualien City where the surface trace of the Milun fault ends (Fig. 1), surface breakages are concentrated along the western part of the Dondamen Nightmarket and distributed extensively across the whole Nanbin Park. At a tarred field right north of the nightmarket, a series of N30 - 40°W striking sinistral fissures connected by N50°E striking push-up mole tracks, implying an almost N-S striking PDZ (Figs. 8a and c). South of the tarred field, fractures are located at the western part of the nightmarket and along Ziyou Road. To the southwest of the nightmarket, surface breakages show similar patterns to those at the tarred field with the PDZ strike of ~N15°W (Fig. 8b). Further south, extensive tensional fissures are distributed along Nanbin Road and across Nanbin Park (Fig. 8). The northernmost fissure (~N25°W) along the bicycle route at the eastern side of Nanbin Park is the largest one with extension of several tens of centimeters. This fissure seems to align with the fracture sets in Figs. 8a and b, denoting a likely curved trace of the PDZ.

Fig. 8. Mapping of surface breakages in southern Hualien City. (a) Detailed mapping of surface fractures on the tarred field north of the Dongdamen Nightmarket. Inset shows the conceptual setting of the stress field and structure orientations. (b) Detailed mapping of surface fractures on Ziyou Road. Inset shows the conceptual setting of the stress field and structure orientations. (c) Aerial photo showing surface fractures at (a).

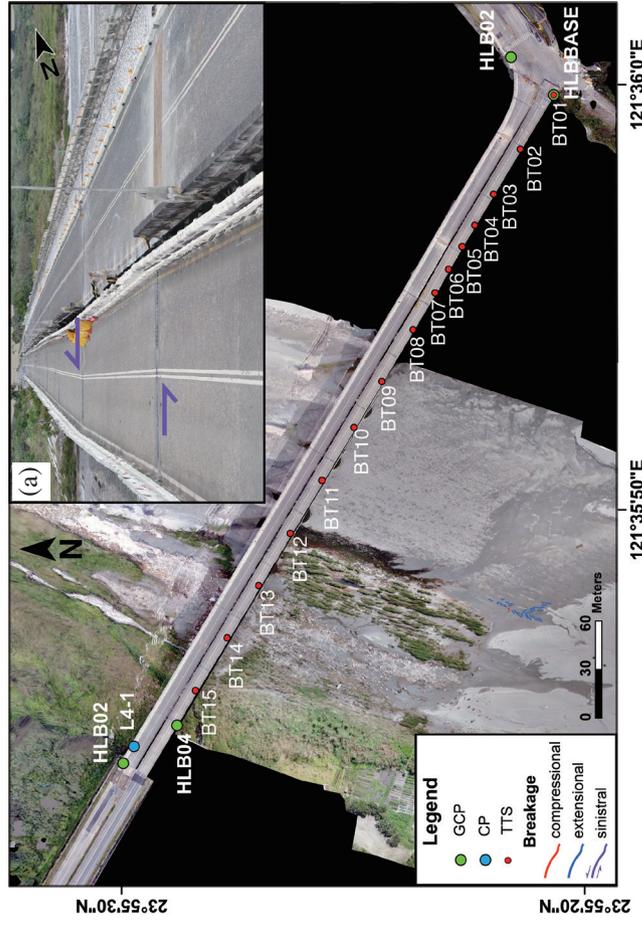
In Hualien River, the surface ruptures offset Hualien Bridge and broke the surface of the western floodplain, suggesting that the northern segment of the Longitudinal Valley fault (Shyu et al. 2016) or Linding fault (CGS 2012) is active during the earthquake. According to our orthoimages and 3D model, the forth bridge segment from the east is offset in a sense of left-lateral strike-slip motion, indicating the fault trace ran below this bridge segment (Fig. 9a). In addition, we measured the amount of sinistral offset by using a Leica TCRA 1201+ R1000 Total Station. We measured along the

Fig. 9. Mapping of surface breakages around Hualien Bridge. Red points are survey locations by using a Total Station. (a) 3D model of Hualien Bridge showing left-lateral offset.

western side line and estimated ~70-cm offset (Fig. 10). In the western floodplain south of the bridge, dense surface breakages are present in a short distance of ~40 m (Fig. 9). This set of breakages seem to be parallel to the Linding fault but out of alignment with the offset bridge segment. Thus, the breakages in the floodplain may not represent the location of the surface trace of the Linding fault.

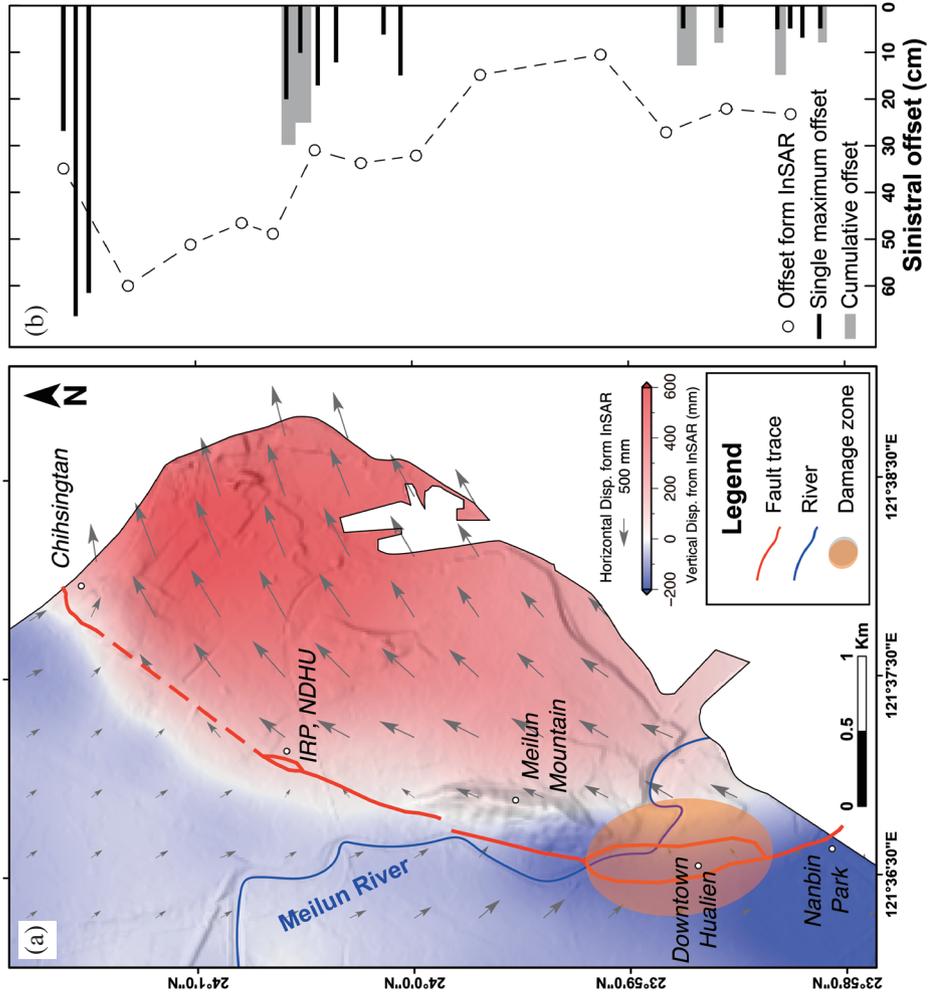
In addition to the orientation changes of the fault trace, amount of slip varies along the strike of the fault. Since we mainly mapped surface fractures based on orthoimages, we estimate along-strike sinistral offsets of single and accumulative fractures (e.g., Angelier et al. 2004) (Fig. 11b). The ruptures in the north show significant sinistral offsets of more than 60 cm and the amount of sinistral slip decreases toward south. It is difficult to estimate slip amount around the areas near Meilun Mountain where surface fractures display compression features or even slightly dextral movements. The ruptures around eastern downtown Hualien is extensively distributed (Fig. 7) so the estimated slip here may be underestimated. In addition, we estimate left-lateral fault slip based on surface displacements derived from InSAR (Yen et al. 2018) for comparison. We compute the differences of the horizontal displacements parallel to the direction of fault strikes across the Milun fault. The comparison indicates that the estimated sinistral fault movements derived from our UAS photogrammetry and InSAR are consistent (Fig. 11b), showing the tendency of large offset to the north and smaller

Fig. 11. Along-strike slip distribution derived from our mapping results. (a) Fault trace of the 2018 Hualien earthquake. Grey vectors are horizontal displacements derived from InSAR and background colors indicate vertical displacement derived from InSAR (Yen et al. 2018). (b) Estimated sinistral offset along the fault. Solid black lines indicate single offset and the thick grey lines indicate cumulative offset of parallel structures. White circles and dashed line are estimated offset from the InSAR result.

offset to the south. For the vertical offset, we only observe obvious uplift along Lane 53 of Chihsing Street. Other compressional features seem to be more like push-up mole tracks (e.g., Fig. 5). The observed uplift feature in Chihsingtan is consistent with preliminary field investigations (CGS 2018; ETEC 2018). Unfortunately, the feature is right in front of local buildings so the 3D model produced by the SfM-MVS method is distorted, making us difficult to estimate vertical offsets directly from the 3D model.

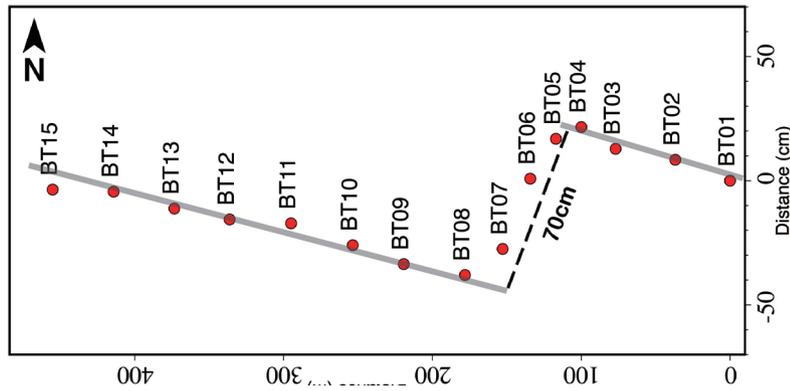
Fig. 10. Survey results of the total station along Hualien Bridge, showing sinistral offset of ~70 cm. Absolute coordinates are derived from RTK-GPS measurements at BT01.
