NOTES AND CORRESPONDENCE

A Preliminary Report on the Chiufenershan Landslide Triggered by the 921 Chichi Earthquake in Nantou, Central Taiwan

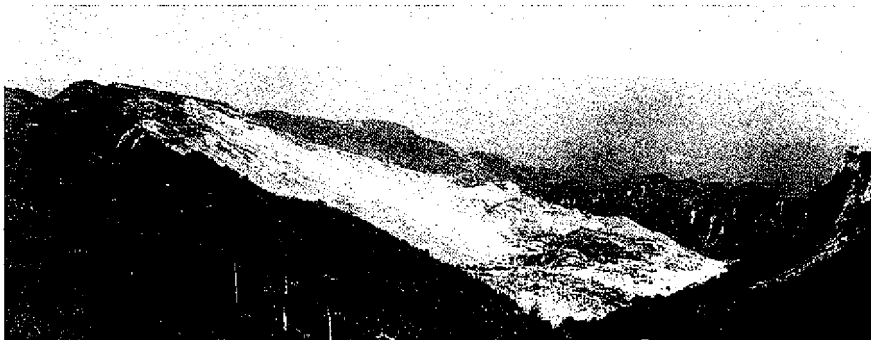
Photo. 1. A distant view of the Chiufenershan landslide from south toward north.

The Chiufenershan landslide is one of the largest triggered by the 921 earthquake. Located in the hilly region of Nankang village, the Kuohsin township of Nantou Hsien (Fig. 1), it is basically a dip-slope translational rock slide, covering a total area of some 200 hectares, and involving the displacement of 30 million cubic meters of rock masses (photo. 1). The sliding part totaled about 75 hectares, ranging in elevations between 500 to 1000 m above

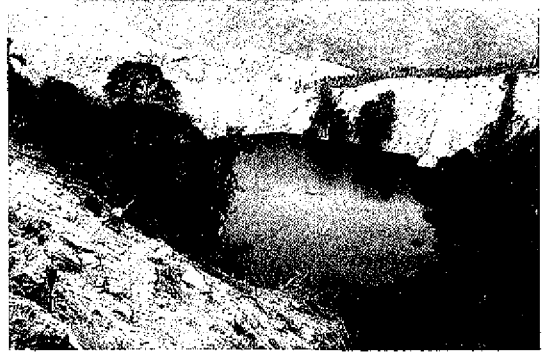
Photo. 3. The Chiutzaihu stream dammed lake.

mean sea level, in which on average 30 to 50 m thick rock masses came off. Rock masses which had slid down from the upper dip-slope area were then choked and deposited on the lower narrow valley gorge, resulting in the formation of a natural earth dam with maximum height of 175 m (photo. 2). Two barrier lakes were also formed on two dammed streams (photos. 3 and 4).

The Shetzekeng stream and its tributary the Chiutzaihu stream were both blocked, and two temporary barrier lakes were formed (photos. 3 and 4). In addition, a ponded elongated depression, located adjacent to the accumulated sliding masses, was also formed (photo. 12).

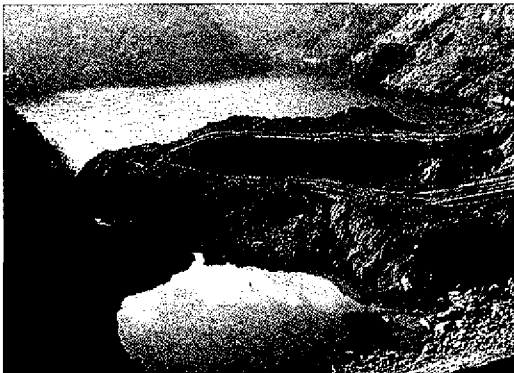
Photo. 4. The Shetzekeng stream dammed lake.

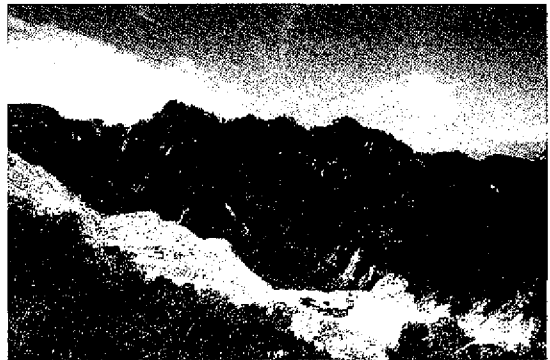
Photo. 5. Ridge relief expressed by the three massive sandstones of the Shihmen Formation is on the middle part. It is located on the east limb of the Taanshan syncline.

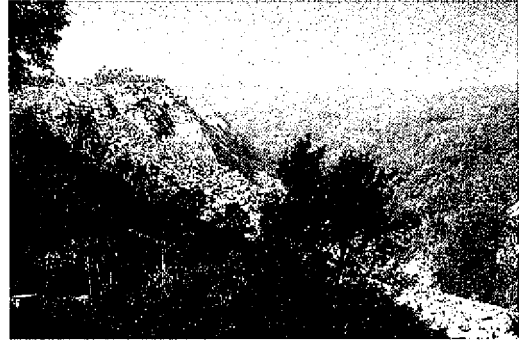
Photo. 7. Rock and debris falls occurred in the northern part.

Other types of landslide, viz rock and debris falls, were also observed, which sporadically occurred only at the north marginal part of the slide area (photo. 7). In this area, rocks first slid along the bedding immediately after the main shock with an average slide distance of about 150 m (photo. 8), followed by blocking and part bulging by the stable-standing rock strata of the east limb of the Taanshan syncline (photo. 9). Thereafter under no lateral constraint conditions, in time high-angled fissures and fractures were gradually opened and deepened along pre-existing joints (photos. 10 and 11). At about 3 a.m., the northern margin of the above transported rock masses eventually toppled and collapsed into a small adjoining gully, forming rock and debris falls of yet another landslide (photo. 7).

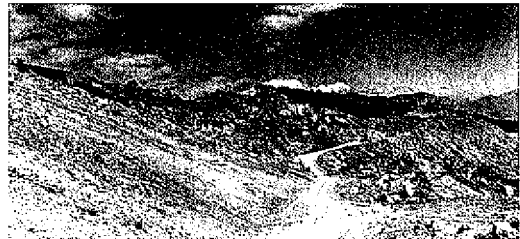
Photo. 9. The northern rock slide and bulge, viewing from south toward north.

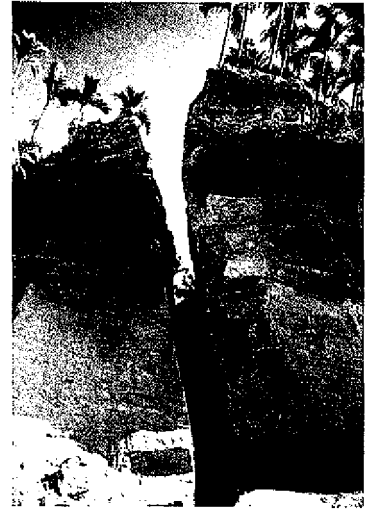
Photo. 11. A deep-seated, opened high-angle joint in the slid rock masses on the northern part.
