Investigating the Milun Fault: The coseismic surface rupture zone of the 2018/02/06 M_L 6.2 Hualien earthquake, Taiwan

Huang, S.-Y., J.-Y. Yen, B.-L. Wu, I.-C. Yen, and R. Y. Chuang, 2019: Investigating the Milun Fault: The coseismic surface rupture zone of the 2018/02/06 M_L 6.2 Hualien earthquake, Taiwan. *Terr. Atmos. Ocean. Sci.*, 30, 311-335, doi: 10.3319/TAO.2018.12.09.03

ABSTRACT

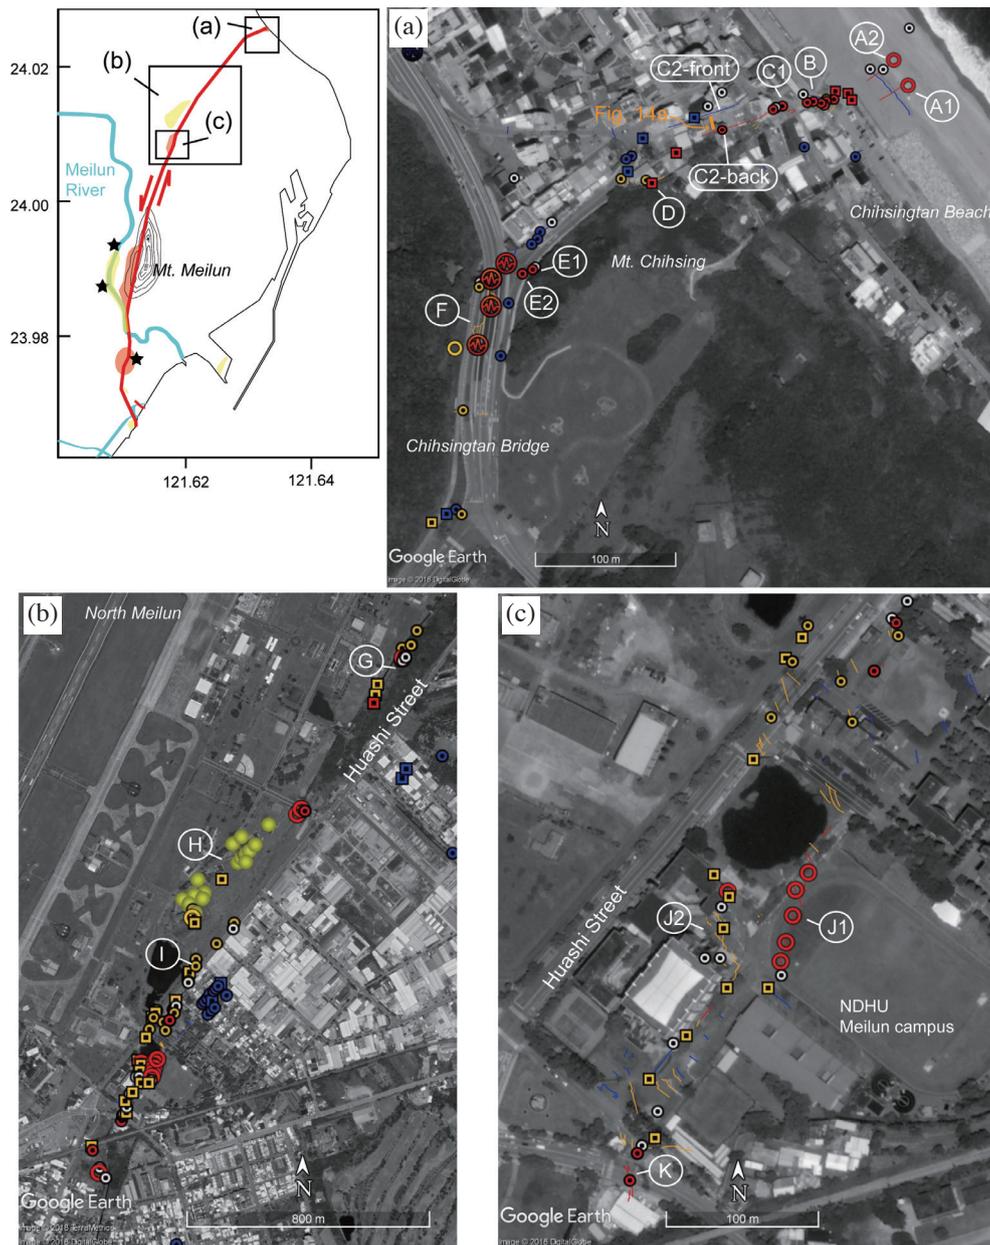
The northernmost rupture on-land occurred at the Chihsingtang Beach area (Fig. 3a) where two parallel lineaments of fault trace were observed on the gravel beach with a 30-cm-sinistral (site A1, Fig. 4a) and a 20-cm-uplift (site A2, Fig. 4b) offset, respectively. The dipping direction of the fault plane can be observed to east but the actual angle is hard to estimate because of the unconsolidated nature of gravel beach.

resulted in 80-cm-compression in front of the houses (site C2-front; point 15; Fig. 4e). The preliminary report from CGS (2018) estimated the amount of vertical offset to be 80 cm according to the shortening features. However, we suspect that the vertical slip in this area should be smaller as we can trace the rupture from C1 all the way through the back of the houses (site C2-back; point 565) and an apparent 27-cm-uplift of the floor base was recorded at one of the tilted houses when the repairing team attempted to excavate the base of the tilted building and lift the floor back to level with arrays of hydraulic lifting jacks. The thrust surface rupture lifted the rear corner of the house and caused the front corner of the building to push against the tarred road, resulting prominent compressional damage along the front of the houses. The net vertical offset near site C2 therefore should be in the range of 20 (max. amount at site A) to 40 (max. amount at site C1) cm and we identified the 80-cm-compression as the category 3 damage which is not directly referred as the surface rupture (Fig. 3a).

Fig. 3. Maps showing damage points in the north segments. (a) Damage points in the Chihsingtan Beach area. The location of the excavation is labelled (Fig. 14a). (b) Damage points in the north Meilun area. (c) Close-up map showing damage points and rupture lines in the campus of NDHU.

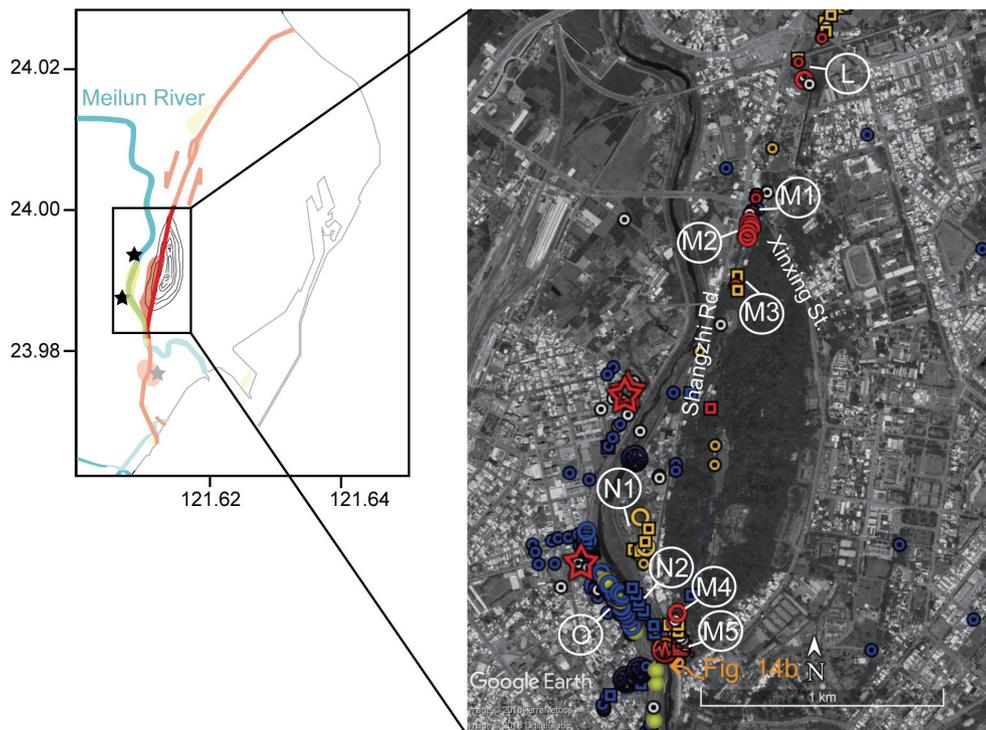
The rupture appeared on the west flank of Mt. Meilun at the intersection of Shangzhi Rd. and Xinxing St. and produced a max. 15-cm-sinistral offset with S-shaped moletracks on the tarred road (site M1, Fig. 7b). The surface damage can be traced southward as a series of northwest-striking en-echelon tensional shears on the bare ground of a banana field within a total length of ca. 90 m (site M2, Fig. 7c). Most of the tensional shears were about 2 m long (max. 20 m) and displayed opening of 1 - 20 cm. The fault trace ran across the Shangzhi Water Purification Plant and extended southward to the hillside of Mt. Meilun (site M3, Fig. 7d). The rupture can be continuously traced until the southern tip of Mt. Meilun. At site M4 (Fig. 7e), the surface rupture cut through a meadow, causing the tilt of streetlight pole, the toppling of the bushes, and an offset of 2-cm-sinistral of the pavement bricks. Prolonged surface deformation such as tensional fissures and Riedel shears can be observed across the Martyrs' Shrine (site M5, Fig. 7f).

Fig. 6. Close-up maps showing the damage points in the Mt. Meilun area.

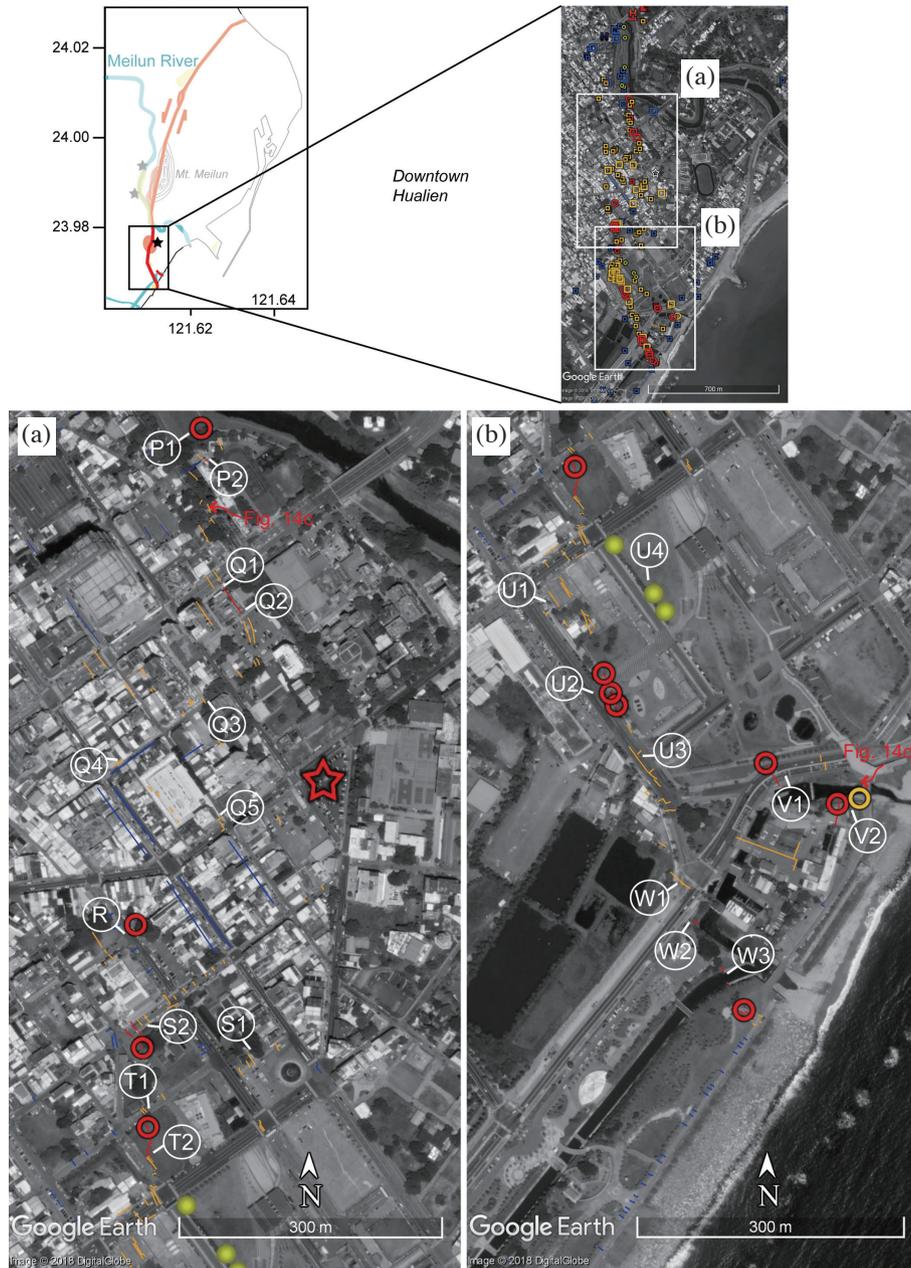
Fig. 8. Maps showing damage zones in downtown area. (a) Map showing the distribution of ruptures from sites P to T. In order to better visualize the fault trace, only rupture lines and points with surface rupture damage are plotted here. (b) Map showing the distribution of ruptures from sites U to W.

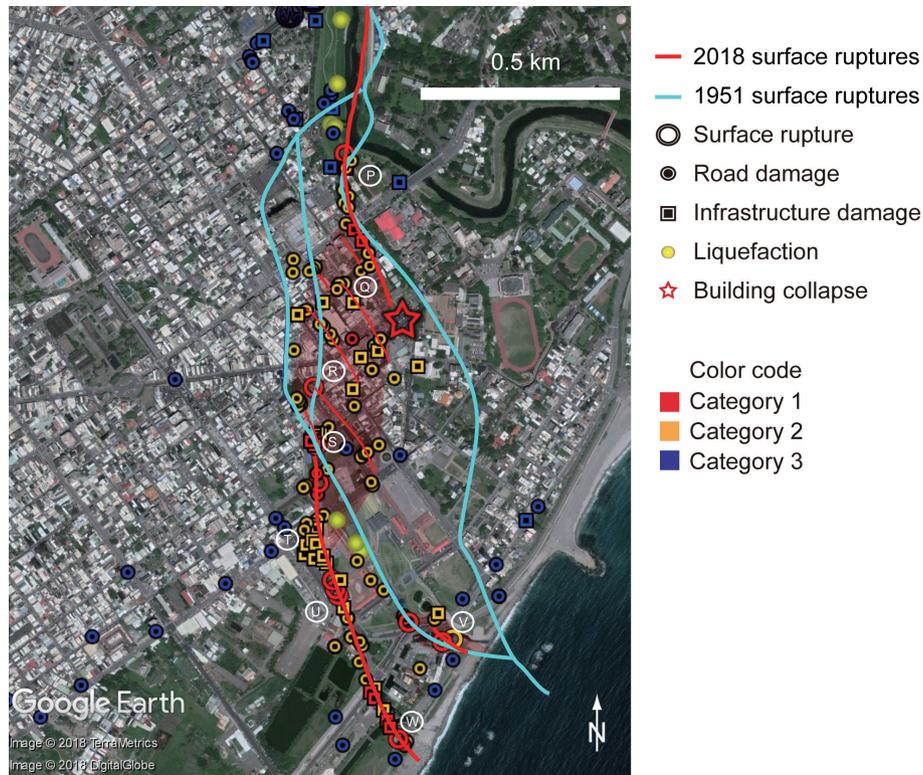
Similarly, the ruptures of the 2018 were arranged as overlapping step-overs in the downtown region, forming a linking damage zone with several subsidiary traces in a wide transpressional area. Figure 15 shows that between sites P and T, most of the 2018 damage points located within the damage zone defined by the 1951 earthquake but not necessarily on the three branches. We argue that the previously mapped fault segments may not really reflect the location of the 1951 surface ruptures because the outcrops were obscured. However, the extension of the three branches presented a first order enveloping range of the damage area. The 2018 surface ruptures provide a refined surface mapping with a much higher resolution in this aspect and suggest that the damage assessment in downtown Hualien should emphasize more on segmented faults with distributed slip than a single through-going fault.

Fig. 15. The fault traces of the 1951 and the 2018 earthquakes.
